HISTORIC RESOURCES INVENTORY
BUILDING AND STRUCTURES
 HIST-6 NEW 5/77

STATE OF CONNECTICUT
CONNECTICUT HISTORICAL COMMISSION
 59 SOUTH PROSPECT STREET, HARTFORD, CONNECTICUT 06106
 (203) 566-3005

| THOMPSON | | DEACON JESSE BOLLES HOUSE | |
| 984 QUADDICK ROAD | | (40 QUADDICK RO.) | 105/32-34 |

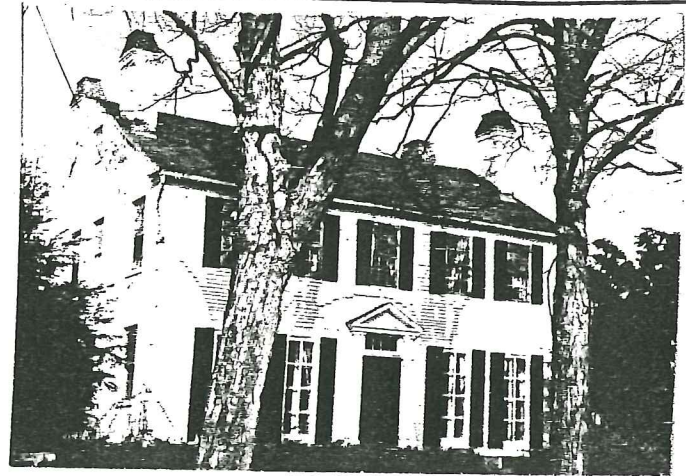
| | VIEW NE; NW (barn) | NEGATIVE ON FILE G16; G19 (barn) | |

Five-bay facade, central entry. Left and right bays paired and offset slightly towards corners of house. First floor has tall four-pane door-sized windows, second has 6-over-6 sash.

Second floor windows are located immediately under cornice detailing. Entry has fluted pilasters with entasis, glazed transom with small rectangular panes. Small pedimented peak above entry has molded cornice, delicate dentils cut to plumb under rakes. Door obscured by wooden shutters. House has wooden quoins, plain frieze with central molding, delicate dentil course, molded cornice with partial return.

Brick end walls, four large brick chimneys. End walls are laid up in common bond with occasional header courses. End-wall window openings have stone sills, splayed brick lintels. Small cross-gabled one-story shed/wing to rear. Victorian barn with bracketed eaves at right-rear.
