HISTORIC RESOURCES INVENTORY
BUILDING AND STRUCTURES
 HIST-6 NEW 5/77

1. BUILDING NAME (Common)		(Historic)	
THOMPSON		WILLIAM BARBER FARMHOUSE	
2. TOWN CITY	VILLAGE	COUNTY	
THOMPSON	QUADDICK	WINDHAM	
3. STREET AND NUMBER (and/or location)		124/32-28	
694 QUADDICK ROAD (190 QUADDICK RO.)

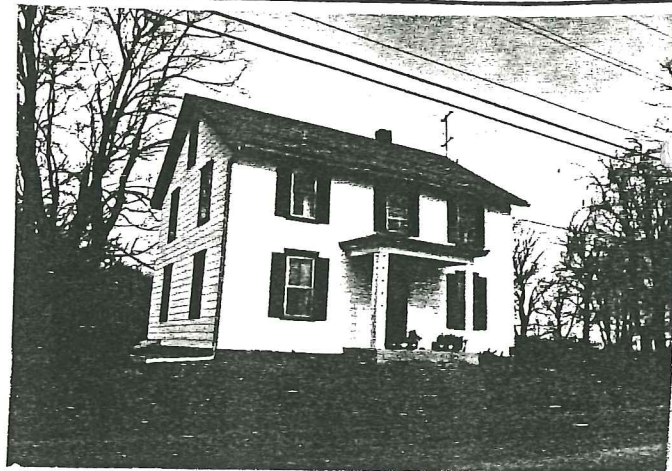
13. INTEGRITY (Location)		WHEN ? (Alterations) IF YES, EXPLAIN	
<input checked="" type="checkbox"/> On original site <input type="checkbox"/> Moved		<input checked="" type="checkbox"/> Yes <input type="checkbox"/> No Later siding, late 19th century porch

Three-bay facade, central entry under flat roofed portico. Portico has lattice columns with drilled patterns in quatrefoil and circle motifs. Sash generally 2-over-2, flat molded window caps, second floor windows high under the eaves. Molded cornice shows no return.

Single brick chimney offset left. Right elevation has Victorian semi-hexagonal bay window over panels. Plain cross-gabled rear wing.
