HISTORIC RESOURCES INVENTORY
BUILDING AND STRUCTURES
 HIST-6 NEW 5/77

IDENTIFICATION	1. BUILDING NAME (Common) KINGS DAUGHTERS HALL		(Historic) KINGS DAUGHTERS HALL		
	2. TOWN CITY THOMPSON		VILLAGE EAST THOMPSON	COUNTY WINDHAM

3. STREET AND NUMBER (and/or location) EAST THOMPSON ROAD (444 EAST THOMPSON RD.)		135/21-14		
	4. OWNER(S) E.T. EARNEST WORKERS CIRCLE/INTL. ORDER OF KINGS DAUGHTERS & SONS, INC. <input type="checkbox"/> Public <input checked="" type="checkbox"/> Private

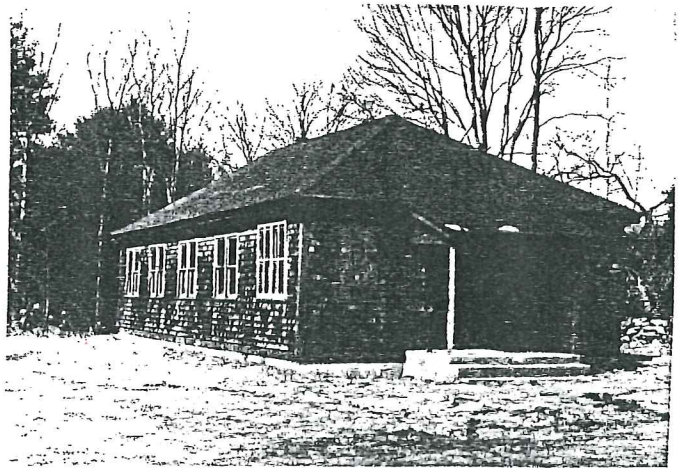
11. NUMBER OF STORIES 1		APPROXIMATE DIMENSIONS 24' x 50'			
12. CONDITION (Structural) (Exterior)					
<input type="checkbox"/> Excellent <input checked="" type="checkbox"/> Good <input type="checkbox"/> Fair <input type="checkbox"/> Deteriorated <input type="checkbox"/> Excellent <input type="checkbox"/> Good <input checked="" type="checkbox"/> Fair <input type="checkbox"/> Deteriorated

13. INTEGRITY (Location)		WHEN ?	(Alterations)	IF YES, EXPLAIN	
<input checked="" type="checkbox"/> On original site <input type="checkbox"/> Moved ?			<input checked="" type="checkbox"/> Yes <input type="checkbox"/> No	Later concrete steps, foundation

PHOTO	PHOTOGRAPHER Mark McDonough		DATE 1986
	VIEW NW	NEGATIVE ON FILE J10	
COMPILED BY	NAME Mark McDonough		DATE 1986
	ORGANIZATION Town of Thompson, Connecticut		
	ADDRESS
