**HISTORIC RESOURCES INVENTORY
BUILDING AND STRUCTURES**

IDENTIFICATION	1. BUILDING NAME (Common) _____ (Historic)	
	2. TOWN CITY THOMPSON	VILLAGE E. THOMPSON
	3. STREET AND NUMBER (and/or location) 1206 EAST THOMPSON ROAD (196 EAST THOMPSON RD.) 137/21-25C

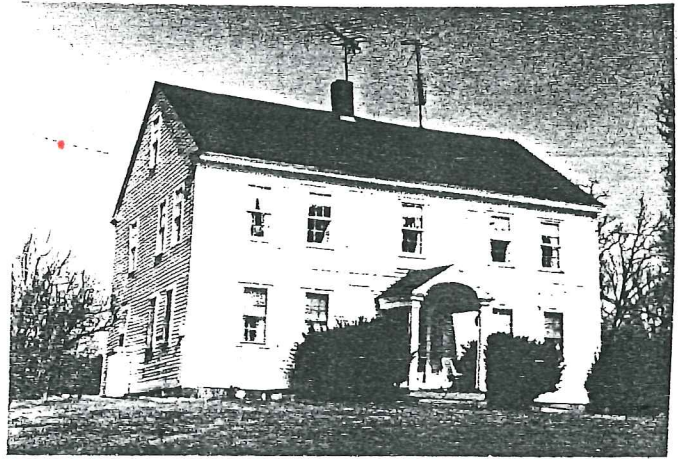
PHOTO	PHOTOGRAPHER Mark McDonough		DATE 1986
	VIEW N	NEGATIVE ON FILE J5	
COMPILED BY	NAME Mark McDonough		DATE 1986
	ORGANIZATION Town of Thompson, Connecticut		
	ADDRESS

11. NUMBER OF STORIES 2 1/2	
	APPROXIMATE DIMENSIONS 40' x 24'	
	12. CONDITION (Structural) _____ (Exterior)	
	<input type="checkbox"/> Excellent <input checked="" type="checkbox"/> Good <input type="checkbox"/> Fair <input type="checkbox"/> Deteriorated <input type="checkbox"/> Excellent <input checked="" type="checkbox"/> Good <input type="checkbox"/> Fair <input type="checkbox"/> Deteriorated

13. INTEGRITY (Location) _____ WHEN? _____ (Alterations) _____ IF YES, EXPLAIN	
	<input checked="" type="checkbox"/> On original site <input type="checkbox"/> Moved <input checked="" type="checkbox"/> Yes <input type="checkbox"/> No Later sash, entry detail

Five-bay facade, central entry. Window bays paired and offset toward corners of house. Open pediment. Colonial Revival entry portico on paneled square posts with entasis (engaged at house).

Paneled wood door, rectangular sidelights over panels, paneled transom. Sash generally 6-over-6. First floor windows have splayed wood lintels with fluted keyblocks. Second floor windows fitted into molded architrave. Plain frieze; molded cornice shows partial return.
