HISTORIC RESOURCES INVENTORY
BUILDING AND STRUCTURES
 HIST-6 NEW 5:77

STATE OF CONNECTICUT
CONNECTICUT HISTORICAL COMMISSION
 59 SOUTH PROSPECT STREET, HARTFORD, CONNECTICUT 06106
 (203) 566-3005

1. BUILDING NAME (Common) _____ (Historic) _____		
2. TOWN CITY THOMPSON	VILLAGE QUADDICK	COUNTY WINDHAM
3. STREET AND NUMBER (and/or location) 168 QUADDICK ROAD (464 QUADDICK RO.)		143/16-8
4. OWNER(S) O'DAY, WILLIAM G. & MARILYN J., RR2, THOMPSON, CT 06277		<input type="checkbox"/> Public <input checked="" type="checkbox"/> Private
5. USE (Present) Residence (Historic) Residence		
6. ACCESSIBILITY TO PUBLIC:	EXTERIOR VISIBLE FROM PUBLIC ROAD	INTERIOR ACCESSIBLE
<input checked="" type="checkbox"/> Yes <input type="checkbox"/> No	<input type="checkbox"/> Yes <input checked="" type="checkbox"/> No	IF YES, EXPLAIN _____

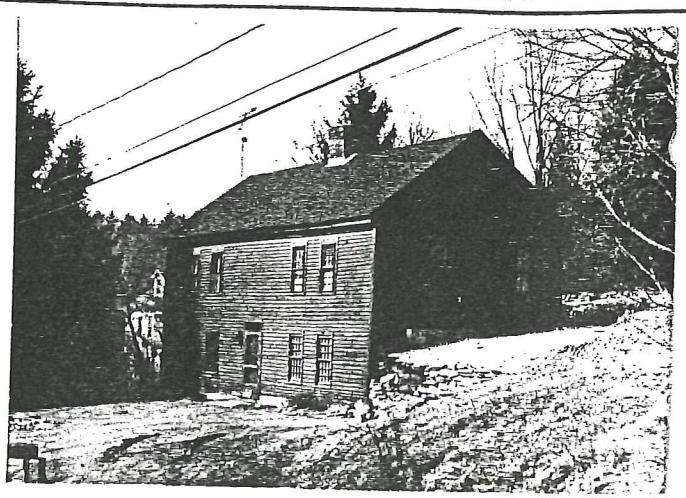
PHOTO	PHOTOGRAPHER Mark McDonough		DATE 1986
	VIEW NW	NEGATIVE ON FILE I23	
COMPILED BY	NAME Mark McDonough		DATE 1986
	ORGANIZATION Town of Thompson, Connecticut		
	ADDRESS

Five-bay facade, central entry; blind bay above entry. Window bays paired. Most exterior fabric represents recent restoration efforts.

Reproduced details include: clapboards, 12-over-12 sash, paneled wood door, rectangular glazed transom, central brick chimney. Molded cornice shows partial return. Walls out of plumb, large post visible at one corner. Some 19th century 2-over-2 sash on side elevations.
