HISTORIC RESOURCES INVENTORY
BUILDING AND STRUCTURES
 HIST-6 NEW 5/77

| IDENTIFICATION | 1. BUILDING NAME (Common) (Historic) | | WILLIAM JOSLIN HOUSE | | |
| | 262 EAST THOMPSON ROAD (670 EAST THOMPSON RD.) | | | | |

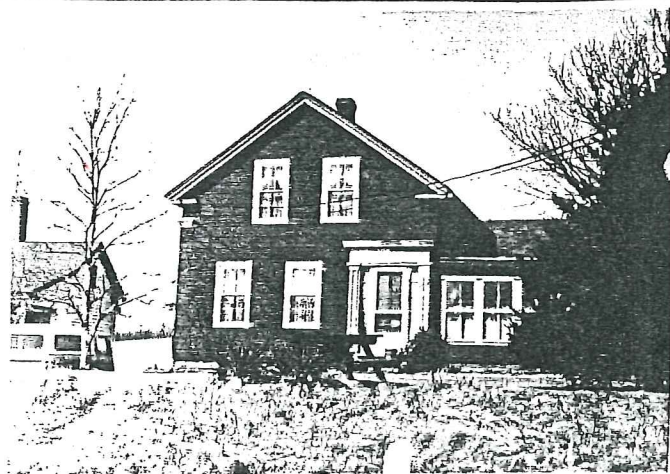
| | VIEW NW | NEGATIVE ON FILE J18 | |

| <input type="checkbox"/> Excellent | <input type="checkbox"/> Good | <input checked="" type="checkbox"/> Fair | <input type="checkbox"/> Deteriorated | <input type="checkbox"/> Excellent <input type="checkbox"/> Good <input type="checkbox"/> Fair <input checked="" type="checkbox"/> Deteriorated | |
| <input checked="" type="checkbox"/> On original site | <input type="checkbox"/> Moved | | <input checked="" type="checkbox"/> Yes <input type="checkbox"/> No | Later siding, deterioration | |

Three-bay facade, right entry. Sash generally old 6-over-6. Entry has rectangular side-lights over panels, paneled wood door. Paneled entry pilasters, wide plain frieze, molded cap. Molded capitals of corner pilasters remain, pilasters removed.

Plain frieze; molded cornice shows partial return. Paired attic windows. One story ell has later framed-in porch.
