**HISTORIC RESOURCES INVENTORY**  
**BUILDING AND STRUCTURES**

STATE OF CONNECTICUT  
**CONNECTICUT HISTORICAL COMMISSION**  
59 SOUTH PROSPECT STREET, HARTFORD, CONNECTICUT 06106  
(203) 566-3005

1. BUILDING NAME (Common)	(Historic)	VANDAL HOUSE
2. TOWN CITY	VILLAGE	COUNTY
THOMPSON	NORTH GROSVENORDALE	WINDHAM
3. STREET AND NUMBER (and/or location)		
20 RED BRIDGE ROAD & VANDAL STREET (8 Red Bridge Ro.)		169/88-75
4. OWNER		
DUQUETTE, ARSENE & DALE, RRL, BOX 682, N. GROSVENORDALE, CT 06255 <input type="checkbox"/> Public <input checked="" type="checkbox"/> Private		
5. USE (Present)		(Historic)
Residence		Residence
6. ACCESSIBILITY TO PUBLIC:	EXTERIOR VISIBLE FROM PUBLIC ROAD	INTERIOR ACCESSIBLE
<input checked="" type="checkbox"/> Yes <input type="checkbox"/> No	<input type="checkbox"/> Yes <input checked="" type="checkbox"/> No	IF YES, EXPLAIN

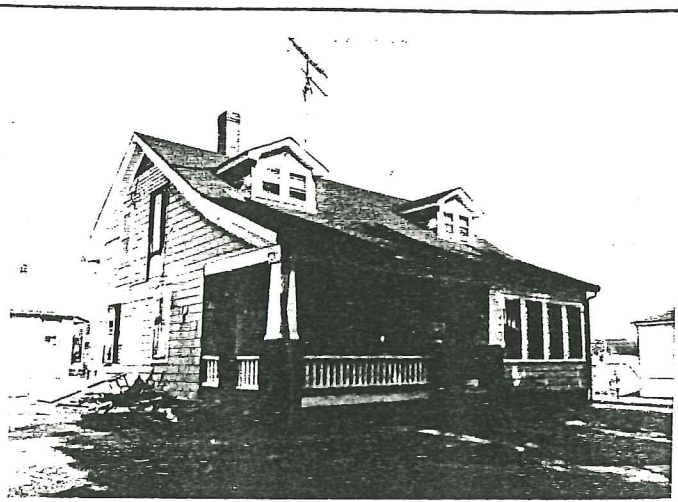
PHOTO	PHOTOGRAPHER Mark McDonough	DATE 1986
	VIEW NE	NEGATIVE ON FILE K14
COMPILED BY	NAME Mark McDonough	DATE 1986
	ORGANIZATION Town of Thompson, Connecticut	
	ADDRESS

Facade dominated by full width porch formed by extension of main roofline. Porch is framed in at right; on left three-bay open porch with entry to right. Sash generally has four narrow vertical panes over one. Entry has rectangular sidelights, wide plain surround, molded cap. Door has single large elliptical pane. Side entry in framed-in portion. Open porch has brick piers and apron, brick steps with round brick newel posts and flared brick stair walls. Battered wood columns. Square rail and balusters. Plain frieze. Molded cornice shows partial return.

Two small gabled roof dormers with 3-over-1 sash. Side elevations heavily altered by recent renovation. Cross-gabled rear wing has overhang on turned posts on right elevation.
