**HISTORIC RESOURCES INVENTORY**  
**BUILDING AND STRUCTURES**  
 HIST-6 NEW 5/77

1. BUILDING NAME (Common) HOSPITAL BLOCK		(Historic) HOSPITAL BLOCK	
2. TOWN CITY THOMPSON		VILLAGE NORTH GROSVENORDALE	COUNTY WINDHAM
3. STREET AND NUMBER (and/or location) 170 MAIN STREET DEMOLISHED - 1988 <u>MAIN ST</u> 169/91-24			
4. OWNER(S) TOWN OF THOMPSON <input checked="" type="checkbox"/> Public <input type="checkbox"/> Private			
5. USE (Present) Vacant (Historic)			
6. ACCESSIBILITY TO PUBLIC:	EXTERIOR VISIBLE FROM PUBLIC ROAD <input checked="" type="checkbox"/> Yes <input type="checkbox"/> No	INTERIOR ACCESSIBLE <input type="checkbox"/> Yes <input checked="" type="checkbox"/> No	IF YES, EXPLAIN

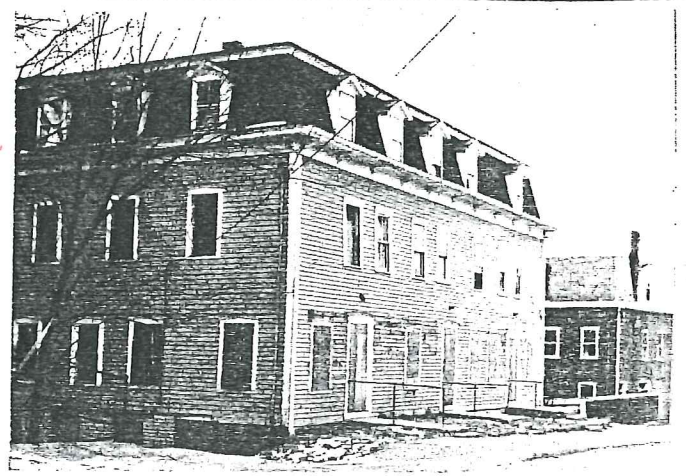
PHOTO	PHOTOGRAPHER Mark McDonough		DATE 1986
	VIEW SE	NEGATIVE ON FILE A9	
COMPILED BY	NAME Mark McDonough		DATE 1986
	ORGANIZATION Town of Thompson, Connecticut		
	ADDRESS

11. NUMBER OF STORIES 2 1/2		APPROXIMATE DIMENSIONS 60' X 32'	
12. CONDITION (Structural) (Exterior)			
<input type="checkbox"/> Excellent	<input checked="" type="checkbox"/> Good	<input type="checkbox"/> Fair	<input type="checkbox"/> Deteriorated
<input type="checkbox"/> Excellent	<input type="checkbox"/> Good	<input type="checkbox"/> Fair	<input checked="" type="checkbox"/> Deteriorated

13. INTEGRITY (Location)			
<input checked="" type="checkbox"/> On original site	<input type="checkbox"/> Moved	WHEN?	(Alterations) <input checked="" type="checkbox"/> Yes <input type="checkbox"/> No IF YES, EXPLAIN
interior gutted, boarded up

First floor has eight bays, entries in second, fourth, and seventh. Second floor has seven bays. Doors and windows have plain pointed-arched surrounds with simple board caps. Plain frieze, overhanging eaves on jigsaw brackets, molded cornice. Five simple gabled roof dormers, spaced asymmetrically.

Side elevations feature similar detailing, raised basement story. Wooden fire stairs to rear.
