HISTORIC RESOURCES INVENTORY
BUILDING AND STRUCTURES
 HIST-6 NEW 5/77

1. BUILDING NAME (Common)		(Historic)	
THOMPSON		DAVID KING HOUSE	
2. TOWN CITY	VILLAGE	COUNTY	
THOMPSON	FABYAN	WINDHAM	
3. STREET AND NUMBER (and/or location)		17&19/84-22	
278 FABYAN ROAD (401 FABYAN RD.)			
4. OWNER(S)			
SULKOWSKI, WALTER et al, RRL, N. GROSVENORDALE, CT 06255			
5. USE (Present)		(Historic)	
Residence		Residence	
6. ACCESSIBILITY TO PUBLIC:			
EXTERIOR VISIBLE FROM PUBLIC ROAD		INTERIOR ACCESSIBLE	
<input checked="" type="checkbox"/> Yes <input type="checkbox"/> No		<input type="checkbox"/> Yes <input checked="" type="checkbox"/> No	
IF YES, EXPLAIN

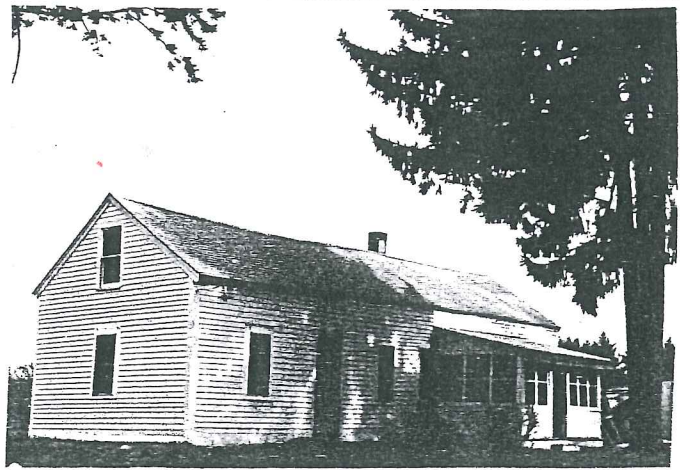
11. NUMBER OF STORIES		APPROXIMATE DIMENSIONS	
1 1/2		52' x 16'	
12. CONDITION (Structural)			
<input type="checkbox"/> Excellent	<input type="checkbox"/> Good	<input type="checkbox"/> Fair	<input checked="" type="checkbox"/> Deteriorated

PHOTO	PHOTOGRAPHER Mark McDonough		DATE 1986
	VIEW NE	NEGATIVE ON FILE K33	
COMPILED BY	NAME Mark McDonough		DATE 1986
	ORGANIZATION Town of Thompson, Connecticut		
	ADDRESS

17 OTHER NOTABLE FEATURES OF BUILDING OR SITE (interior and/or exterior)
 Six-bay facade; entries in second and fifth bays. Sash is mixed 2-over-2 and old 6-over-6. Two-bay glassed-in shed roofed 20th century porch at right corner.
 Entries have paneled wood doors and rectangular glazed transoms. Wide, plain window and entry surrounds. Many details out of plumb, ridge appears to lack ridgepiece. Right elevation has added modern greenhouse/solarium.
