HISTORIC RESOURCES INVENTORY
BUILDING AND STRUCTURES
 HIST-6 NEW 5/77

STATE OF CONNECTICUT
 CONNECTICUT HISTORICAL COMMISSION
 59 SOUTH PROSPECT STREET, HARTFORD, CONNECTICUT 06106
 (203) 566-3005

1. BUILDING NAME (Common) _____ (Historic)	
2. TOWN CITY THOMPSON	VILLAGE NORTH GROSVENORDALE
3. STREET AND NUMBER (and/or location) 78 BUCKLEY HILL ROAD (38 BUCKLEY HILL RD.) 61/59 + 62-10

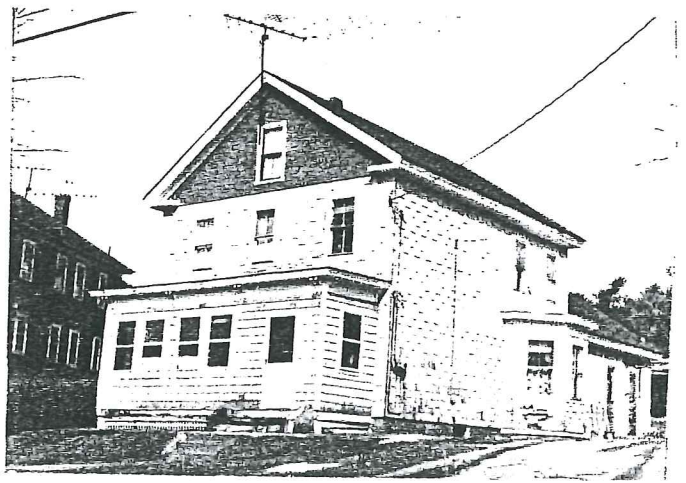
PHOTO	PHOTOGRAPHER Mark McDonough		DATE 1986
	VIEW NW	NEGATIVE ON FILE D17	
COMPILED BY	NAME Mark McDonough		DATE 1986
	ORGANIZATION Town of Thompson, Connecticut		
	ADDRESS

Three-bay facade, full-width one-story framed-in porch has flat roof with plain frieze, molded cornice with small paired jigsawn brackets. Sash is generally 2-over-2, 1-over-1 in porch. Roof has molded cornice with partial return.

Side elevations have one-story bay windows to rear. Lower parallel rear wing is plain.

Architecturally, it is modest and considerably altered, but features such as the bay windows and the bracketed cornice of the porch testify to its Victorian origins.
