HISTORIC RESOURCES INVENTORY
BUILDING AND STRUCTURES
 HIST-6 NEW 5/77

STATE OF CONNECTICUT
CONNECTICUT HISTORICAL COMMISSION
 59 SOUTH PROSPECT STREET, HARTFORD, CONNECTICUT 06106
 (203) 566-3005

1. BUILDING NAME (Common) _____ (Historic)	
2. TOWN CITY THOMPSON	VILLAGE NORTH GROSVENORDALE
COUNTY WINDHAM	
3. STREET AND NUMBER (and/or location) 25 POMPEO ROAD (440 POMPEO RD.) 77/62-55	
4. OWNER(S) HULSE, LAWRENCE W. & LINDA S., RRI, N. GROSVENORDALE, CT 06255 <input type="checkbox"/> Public <input checked="" type="checkbox"/> Private	
5. USE (Present) _____ (Historic) Residence Residence	
6. ACCESSIBILITY TO PUBLIC: <input checked="" type="checkbox"/> Yes <input type="checkbox"/> No	EXTERIOR VISIBLE FROM PUBLIC ROAD <input type="checkbox"/> Yes <input checked="" type="checkbox"/> No
INTERIOR ACCESSIBLE <input type="checkbox"/> Yes <input checked="" type="checkbox"/> No IF YES, EXPLAIN

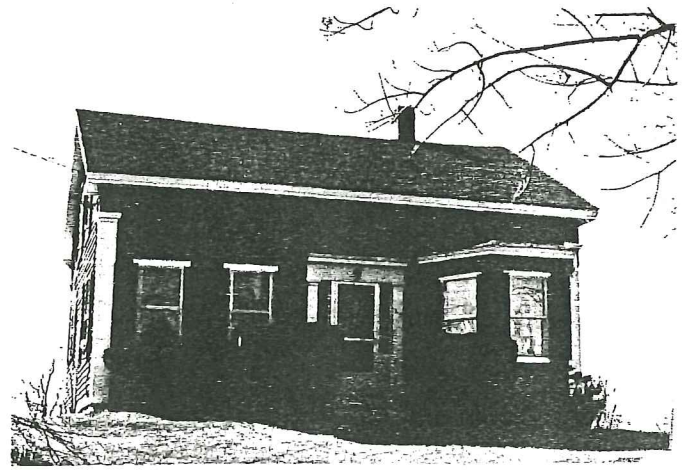
13. INTEGRITY (Location) _____ WHEN? _____ (Alterations) _____ IF YES, EXPLAIN	
<input checked="" type="checkbox"/> On original site <input type="checkbox"/> Moved	<input checked="" type="checkbox"/> Yes <input type="checkbox"/> No New sash, later bay window

Four-bay facade, central sidelighted entry with plain pilasters, in third bay, wide plain lintel with molded cap. Sash generally recent 1-over-1. Flat roofed bay window in fourth bay. Plain corner pilasters with molded capitals. Wide plain frieze. Molded cornice shows partial return. Side elevations plain with same old 6-over-6 sash.
