HISTORIC RESOURCES INVENTORY
BUILDING AND STRUCTURES
 HIST-6 NEW 5/77

STATE OF CONNECTICUT
CONNECTICUT HISTORICAL COMMISSION
 59 SOUTH PROSPECT STREET, HARTFORD, CONNECTICUT 06106
 (203) 566-3005

IDENTIFICATION	1. BUILDING NAME (Common) _____ (Historic) THOMAS DAY HOUSE	
	2. TOWN CITY THOMPSON	VILLAGE THOMPSON
	3. STREET AND NUMBER (and/or location) 106 BALLARD ROAD (38 BALLARD RD.) 87/53-9

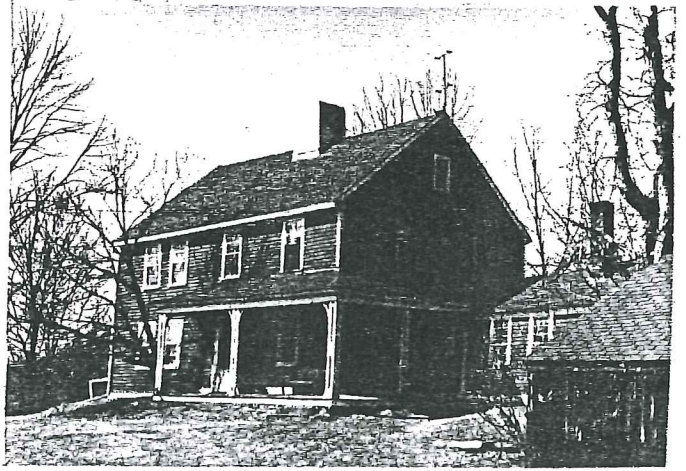
11. NUMBER OF STORIES 2 1/2 APPROXIMATE DIMENSIONS 35' x 26'		
12. CONDITION (Structural) _____ (Exterior) _____		
<input type="checkbox"/> Excellent <input checked="" type="checkbox"/> Good <input type="checkbox"/> Fair <input type="checkbox"/> Deteriorated <input type="checkbox"/> Excellent <input type="checkbox"/> Good <input checked="" type="checkbox"/> Fair <input type="checkbox"/> Deteriorated

PHOTO	PHOTOGRAPHER Mark McDonough		DATE 1986
	VIEW NW	NEGATIVE ON FILE K5	
COMPILED BY	NAME Mark McDonough		DATE 1986
	ORGANIZATION Town of Thompson, Connecticut		
	ADDRESS		
20 SUBSEQUENT FIELD EVALUATION:

Four-bay facade, central entry in third bay. Old 6-over-6 sash with some old 12-over-8, 9-over-6 on side elevations. One story porch shelters third and fourth bays, wraps around right corner to shelter side entry. Porch has lattice posts with jigsaw decorative panels, jigsaw post brackets.

Old paneled wood door, plain corner boards, second floor windows abut bed molding. Molded cornice shows partial return. Large central brick chimney. Old one story parallel kitchen wing at right rear.
