HISTORIC RESOURCES INVENTORY
BUILDING AND STRUCTURES
 HIST-6 NEW 5 77

STATE OF CONNECTICUT
CONNECTICUT HISTORICAL COMMISSION
 59 SOUTH PROSPECT STREET, HARTFORD, CONNECTICUT 06106
 (203) 566-3005

IDENTIFICATION	1. BUILDING NAME (Common) (Historic)		JOHN BATES, JR. HOUSE		
	2. TOWN CITY	VILLAGE	COUNTY		
	THOMPSON	THOMPSON	WINDHAM		
	3. STREET AND NUMBER (and/or location)		DATE OF CONSTRUCTION		
	3 ROUTE 193 and MASSACHUSETTS LINE (1406-1408 THOMPSON Rd.)		c. 1800		
DESCRIPTION	4. OWNER(S)		<input type="checkbox"/> Public <input checked="" type="checkbox"/> Private

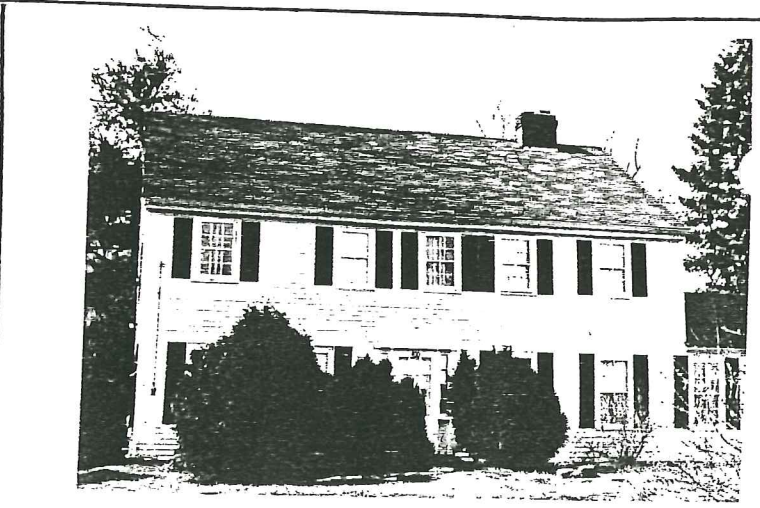
PHOTO	PHOTOGRAPHER Mark McDonough		DATE 1986
	VIEW NW	NEGATIVE ON FILE J26	
COMPILED BY	NAME Mark McDonough		DATE 1986
	ORGANIZATION Town of Thompson, Connecticut		
	ADDRESS

17 OTHER NOTABLE FEATURES OF BUILDING OR SITE (interior and/or exterior)
 Five-bay facade (spaced irregularly on second floor), central entry. Rectangular side-lights flanked by narrow fluted and paneled pilasters (outer pilasters paired).
 Pilasters have molded architrave, plain frieze, molded cornice. Above, molded transom bar and carved semi-elliptical sunburst with molded surround, keyblock with carved heart and arrow design. Sash generally 6-over-6. Second floor windows located high under eaves. Cornice detailing boxed over with modern siding.
 Single chimney near right end of ridge.
 Interiors were extensively re-finished c. 1940 and feature enameled composition board paneling resembling formica. Foundation of massive central chimney remains.
