**HISTORIC RESOURCES INVENTORY**  
**BUILDING AND STRUCTURES**  
HIST-6 NEW 5/77

STATE OF CONNECTICUT  
**CONNECTICUT HISTORICAL COMMISSION**  
59 SOUTH PROSPECT STREET, HARTFORD, CONNECTICUT 06106  
(203) 566-3005

1. BUILDING NAME (Common)		(Historic)	
JOSIAH COMINS FARM			
2. TOWN CITY	VILLAGE	COUNTY	
THOMPSON	THOMPSON	WINDHAM	
3. STREET AND NUMBER (and/or location)			
757 SUNSET HILL ROAD (116 SUNSET HILL RD.)		103/40-3C	
4. OWNER(S)			
SCHOPPE, IRVING J. & JUNE A., RR2, THOMPSON, CT 06277			
<input type="checkbox"/> Public <input checked="" type="checkbox"/> Private			
5. USE (Present)		(Historic)	
Residence		Residence	
6. ACCESSIBILITY TO PUBLIC:			
EXTERIOR VISIBLE FROM PUBLIC ROAD		INTERIOR ACCESSIBLE	
<input checked="" type="checkbox"/> Yes <input type="checkbox"/> No		<input type="checkbox"/> Yes <input checked="" type="checkbox"/> No	
IF YES, EXPLAIN

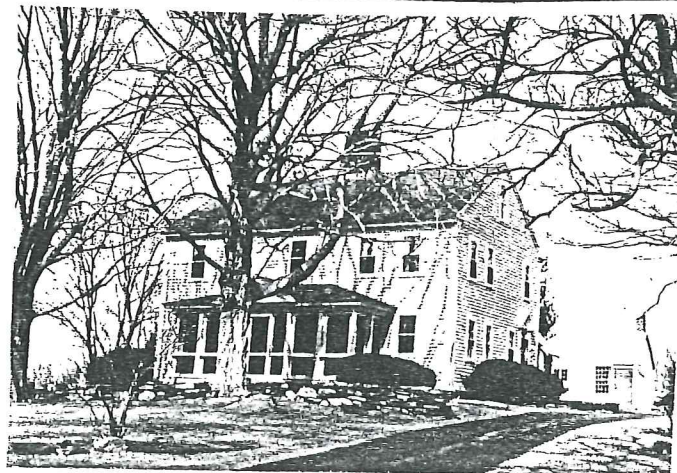
11. NUMBER OF STORIES			
2 1/2			
APPROXIMATE DIMENSIONS			
40' x 29'			
12. CONDITION (Structural)			
<input type="checkbox"/> Excellent		<input checked="" type="checkbox"/> Good	
<input type="checkbox"/> Fair		<input type="checkbox"/> Deteriorated	
(Exterior)			
<input type="checkbox"/> Excellent		<input checked="" type="checkbox"/> Good	
<input type="checkbox"/> Fair		<input type="checkbox"/> Deteriorated

13. INTEGRITY (Location)			
<input checked="" type="checkbox"/> On original site		<input type="checkbox"/> Moved	
WHEN ?		(Alterations)	
<input checked="" type="checkbox"/> Yes		<input type="checkbox"/> No	
IF YES, EXPLAIN			
Recent sash, later porch, repairs

Five-bay facade, central entry. Sash generally recent 6-over-6. Window bays paired and offset towards corners of house. Entry has paneled wood door, rectangular sidelights, is sheltered by three-bay screened-in porch with Tuscan columns and central pedimented peak.

Second floor windows abut plain frieze. Molded cornice shows partial return. Central brick chimney. Right elevation has side entry with heavy paneled door, semi-circular radial glazed fanlight, plain pilasters, and open-pediment hood. Lower two story cross-gabled rear wing with Colonial Revival detailing adjoins modern garage.
