**HISTORIC RESOURCES INVENTORY
BUILDING AND STRUCTURES**

| IDENTIFICATION | 1. BUILDING NAME (Common) (Historic) | | THE ACADEMY BUILDING | | |

ACADEMY BUILDING

| | 3. STREET AND NUMBER (and/or location) 1896 ROUTE 193 (south portion) 343 Thompson Rd. 105/33-3 | |

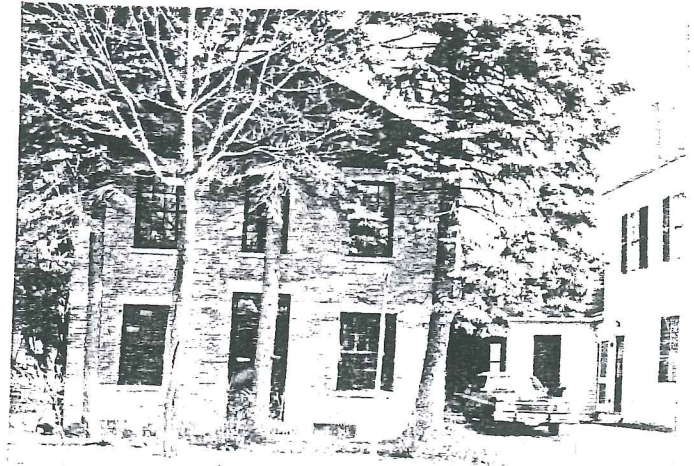
| | VIEW E | NEGATIVE ON FILE E10 | |

| <input type="checkbox"/> Excellent | <input checked="" type="checkbox"/> Good | <input type="checkbox"/> Fair | <input type="checkbox"/> Deteriorated | <input type="checkbox"/> Excellent <input checked="" type="checkbox"/> Good <input type="checkbox"/> Fair <input type="checkbox"/> Deteriorated | |
| <input checked="" type="checkbox"/> On original site | <input type="checkbox"/> Moved | | <input checked="" type="checkbox"/> Yes <input type="checkbox"/> No | Victorian shingles in peak | |

Three-bay facade, central entry. Brick walls laid up in common bond with header courses every tenth course. Sas old 8-over-8, granite sills and lintels. Paneled wood door, transom has modified border-pane glazing. Molded cornice, pedimented peak with staggered-butt shingles. Side elevations feature 6-over-6 sash, first-floor walls blank. At right rear, adjoins house to south through garage/stable wing.

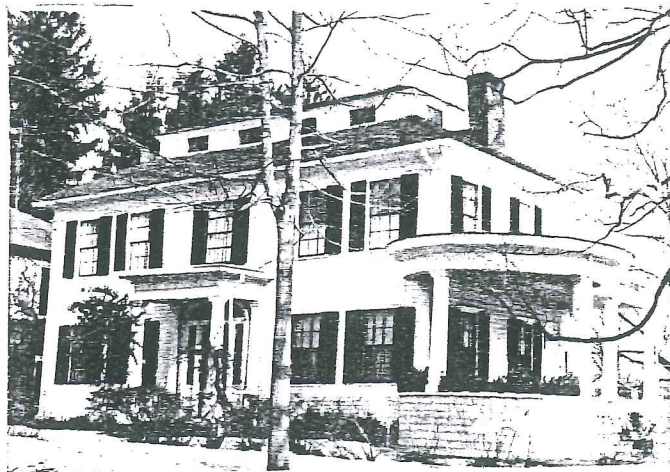
| | VIEW NE | NEGATIVE ON FILE E9 | |

| IF YES, EXPLAIN Victorian right porch | | |

Five-bay facade, central entry. Windows paired and offset towards corners of house. Old 6-over-6 sash, molded window surrounds. Old wide heavy-paneled wood door. Rectangular sidelights with leaded star-and-circle glazing, cast-lead floral decorations. Radial-glazed semi-elliptical fanlight with cast-lead decorations. Sidelights flanked by very slender engaged round columns with flared acanthus-leaf capitals and annular rings. Same above fanlight. Later flat-roofed entry portico on square chamfered posts with entasis, narrow round-arched panels (engaged posts at main wall). Portico has plain frieze with central molding, applied spades under bracketed molded cornice. Turned balusters, molded rail. House has two-story paneled corner pilasters, molded architrave, plain frieze, molded cornice. Four-bay flat-roofed cupola on roof.

Right elevation: one-story flat-roofed porch on tapered square chamfered posts. Porch forms rounded pavillion at right-front; railing has fishscale shingles.
