**HISTORIC RESOURCES INVENTORY**  
**BUILDING AND STRUCTURES**  
 HIST-6 NEW 5 77

STATE OF CONNECTICUT  
**CONNECTICUT HISTORICAL COMMISSION**  
 59 SOUTH PROSPECT STREET, HARTFORD, CONNECTICUT 06106  
 (203) 566-3005

IDENTIFICATION	1. BUILDING NAME (Common) <span style="float: right;">(Historic)</span>		DR. HORATIO HOLLBROOK HOUSE	
	2. TOWN CITY	VILLAGE	COUNTY	
	THOMPSON	THOMPSON	WINDHAM

3. STREET AND NUMBER (and/or location)			105/40-14
	1845 ROUTE 193 (366 THOMPSON Rd.)			
	4. OWNER(S)		<input type="checkbox"/> Public <input checked="" type="checkbox"/> Private	
	KLUG, JOHN P. & RHONDA L., THOMPSON, CT 06277

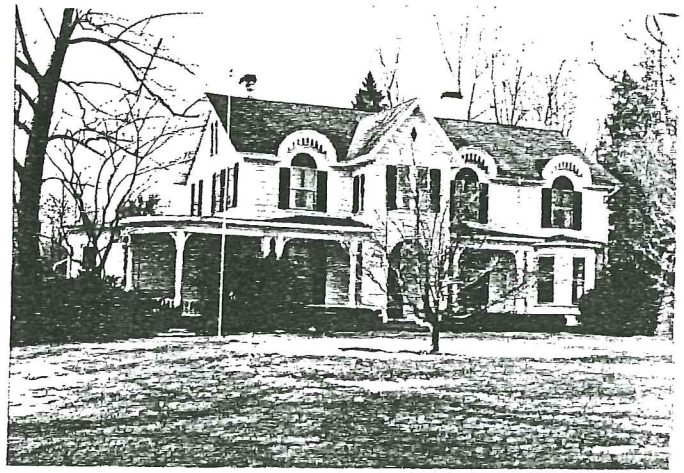
PHOTO	PHOTOGRAPHER Mark McDonough		DATE 1986
	VIEW NW	NEGATIVE ON FILE E21	
COMPILED BY	NAME Mark McDonough		DATE 1986
	ORGANIZATION Town of Thompson, Connecticut		
	ADDRESS

11. NUMBER OF STORIES		APPROXIMATE DIMENSIONS		
2		51' X 26'		
12. CONDITION (Structural) <span style="float: right;">(Exterior)</span>				
<input type="checkbox"/> Excellent	<input checked="" type="checkbox"/> Good	<input type="checkbox"/> Fair	<input type="checkbox"/> Deteriorated	
<input type="checkbox"/> Excellent	<input checked="" type="checkbox"/> Good	<input type="checkbox"/> Fair	<input type="checkbox"/> Deteriorated

13. INTEGRITY (Location)		WHEN?	(Alterations)	
<input checked="" type="checkbox"/> On original site	<input type="checkbox"/> Moved		<input checked="" type="checkbox"/> Yes <input type="checkbox"/> No	
		IF YES, EXPLAIN		
		al. siding, remodelled c. 1857

Four-bay facade, recessed entry in projecting second-bay gabled pavillion. Pavillion has square paired pilasters, small diamond-shaped attic window. Sash generally 2-over-2.

Entry: round-arched opening, double wood doors with small bevelled panes in a complex pattern. One-story porch shelters first and third bays, wraps around left corner to meet rear bay window, forms rounded pavillion at corner. Porch has turned balusters, molded rail. Turned posts generally paired; between bases are panels with decorative star cut-outs. Fourth bay on facade has one-story bay window with pilasters with round-arched panels. First, third, and fourth bay windows are treated as round-arched wall dormers with scalloped vergeboards.
