HISTORIC RESOURCES INVENTORY
BUILDING AND STRUCTURES
HIST-6 NEW 5/77

| 2. TOWN CITY THOMPSON | VILLAGE QUINEBAUG | COUNTY WINDHAM | |
| 3. STREET AND NUMBER (and/or location) 64 ROUTE 197 (176 OLD TURNPIKE) | | 3/77/-6 | |

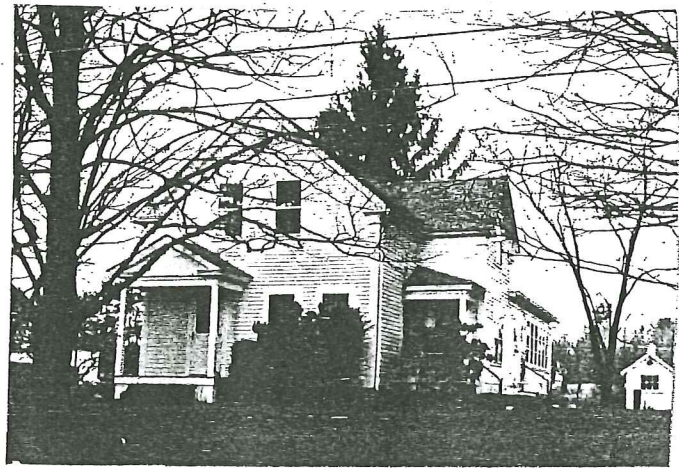
| | VIEW W | NEGATIVE ON FILE H23 | |

| | <p>Three-bay facade, left entry, gabled portico on square posts. Sash generally 2-over-2. Narrow corner pilasters with molded caps. Plain frieze. Molded cornice shows partial return. Fishscale shingles in peak.</p> <p>Left elevation has bevelled one-and-one-half-story bay, squared at rake-ends on simple jigsawn panels. First floor window on bay has stained glass transom. Stained glass border pane stair window. Right elevation has one-and-one-half-story bay window. Large parallel rear wing.</p> | |
