1. BUILDING NAME (Common) (Historic)
 MECHANICSVILLE POWER STATION

STATE OF CONNECTICUT
 CONNECTICUT HISTORICAL COMMISSION
 59 South Prospect Street, Hartford, Connecticut 06106
 HISTORIC RESOURCES INVENTORY FORM
 For Buildings and Structures

CONTINUATION SHEET #19 MECHANICSVILLE POWER STATION
 Item number: _____ Date: _____

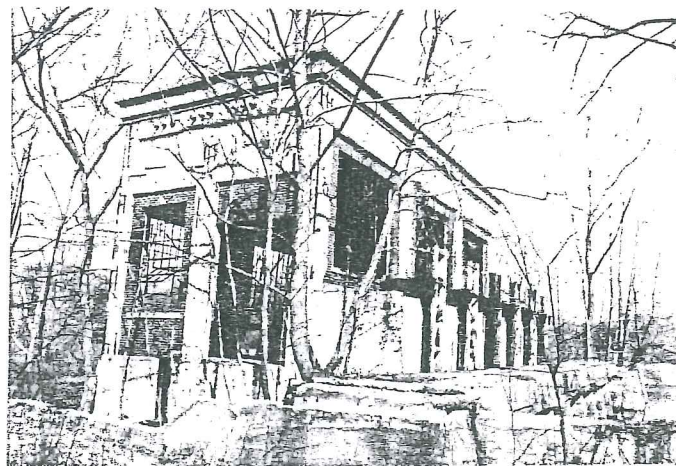
PHOTO	PHOTOGRAPHER Mark McDonough		DATE 1986
	VIEW NE	NEGATIVE ON FILE F21	
COMPILED BY	NAME Mark McDonough		DATE 1986
	ORGANIZATION Town of Thompson, Connecticut		
	ADDRESS

17 OTHER NOTABLE FEATURES OF BUILDING OR SITE (interior and/or exterior)
Reinforced concrete factory construction with brick panels, containing industrial steel sash windows (deteriorated). Poured concrete floor, structural steel roof. Molded concrete cornice.

East and west elevations have two bays, north and south have three. Building stands at the south end of a large stone and concrete dam, still relatively intact. On south elevation, concrete head race with six head gates (deteriorated). All visible interior machinery has been removed, save for one turbine shaft; impossible to determine if turbines remain in place.
