HISTORIC RESOURCES INVENTORY
BUILDING AND STRUCTURES
 HIST-6 NEW 5/77

| 1. BUILDING NAME (Common) (Historic) | | CHARLES R. WOOD HOUSE | |
| 690 WILSONVILLE ROAD (150 WILSONVILLE RD.) | | | |

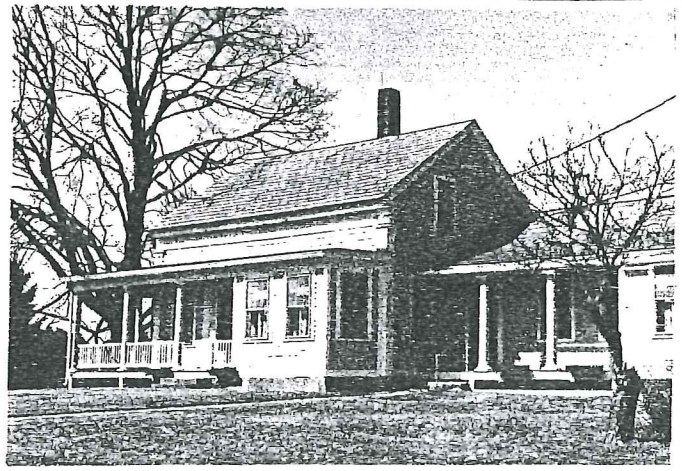
| | VIEW NW | NEGATIVE ON FILE L30 | |

Three-bay facade. Bay window to right, entry offset to left. Sash generally 6-over-2. Door has single large light over panels.

To left of bay window, two-bay one story porch on Tuscan columns. Square balusters, molded rail. Plain corner boards with molded capitals. Plain frieze; molded cornice shows partial return. Lower parallel one-and-one-half-story right wing has open porch on Tuscan columns, framed-in to right.
