**HISTORIC RESOURCES INVENTORY**  
**BUILDING AND STRUCTURES**

| IDENTIFICATION | 1. BUILDING NAME (Common) (Historic) | | DANFORTH BURGESS HOUSE | |
| | 801 WILSONVILLE ROAD (97 WILSONVILLE RD) | | | |

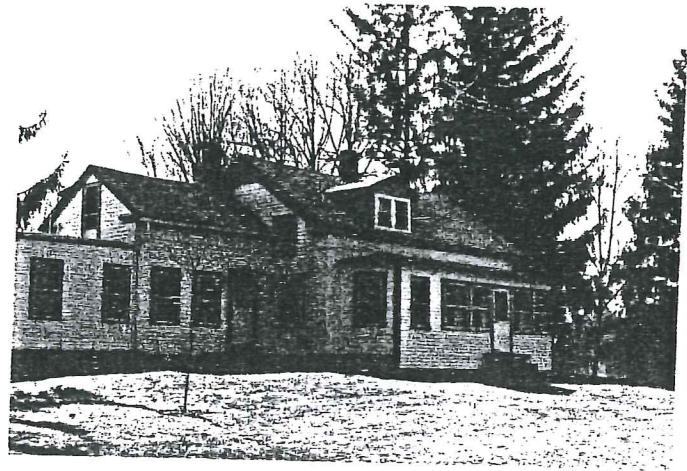
| | VIEW<br>SW | NEGATIVE ON FILE<br>L32 |

Facade covered by full width framed-in porch. Front wall has central entry, bay window to left, two simple windows to right. Sash mixed. Wood door has single large pane over panels. Wide plain corner pilasters with molded capitals. Wide plain frieze. Molded cornice shows partial return.

Most windows on all elevations have paneled surrounds with paneled corner blocks. Lower parallel left wing with similar detailing; one story flat roofed addition at end of wing.

Architecturally, it is considerably altered by the addition of a framed-in front porch, but still shows a variety of Greek Revival detail. The corner pilasters and prominent frieze and cornice were intended to suggest the columns and formal entablatures of a classical Greek temple; their application to a simple ridge-parallel house is typical of northeastern Connecticut. The elaborate window surrounds foreshadow the ornate detailing of the Victorian era.
