HISTORIC RESOURCES INVENTORY
BUILDING AND STRUCTURES
 HIST-6 NEW 5/77

STATE OF CONNECTICUT
 CONNECTICUT HISTORICAL COMMISSION
 59 SOUTH PROSPECT STREET, HARTFORD, CONNECTICUT 06106
 (203) 566-3005

IDENTIFICATION	1. BUILDING NAME (Common) _____ (Historic)	
	2. TOWN CITY THOMPSON	VILLAGE QUINEBAUG
	3. STREET AND NUMBER (and/or location) 155 ROUTE 197 (131 OLD TURNPIKE) 3/81-4

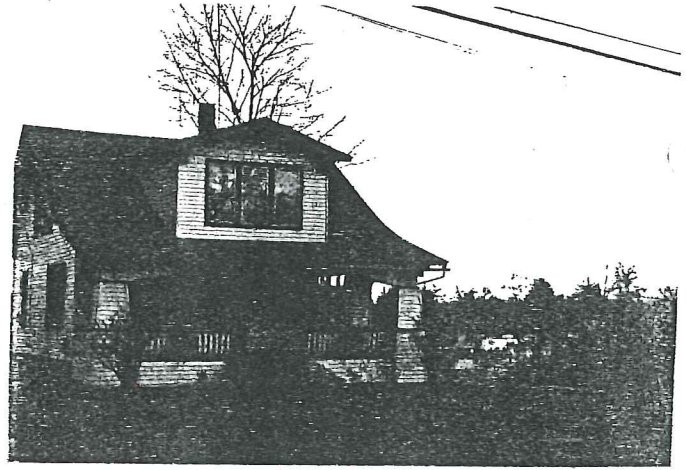
PHOTO	PHOTOGRAPHER Mark McDonough		DATE 1986
	VIEW SE	NEGATIVE ON FILE H29	
COMPILED BY	NAME Mark McDonough		DATE 1986
	ORGANIZATION Town of Thompson, Connecticut		
	ADDRESS

13. INTEGRITY (Location) _____ WHEN? _____ (Alterations) _____ IF YES, EXPLAIN		
<input checked="" type="checkbox"/> On original site <input type="checkbox"/> Moved	<input checked="" type="checkbox"/> Yes <input type="checkbox"/> No Modern siding

Three-bay facade, central entry. Door has single large light over rectangular panels. Three part windows left and right have large fixed panes with glazed transoms, molded wood muntins.

Flared roofline is extended to form full width porch on battered columns. Porch has square balusters, molded rail, shallow round arched openings, valence with vertical beaded boards. Overhanging eaves on exposed stepped purlins. Plain face rafter. Above, large gabled roof dormer with 6-over-1 sash, similar eaves. Left elevation has three part window to front, triple 6-over-1 attic, plain 6-over-1 rear. Right has similar fenestration.
