**HISTORIC RESOURCES INVENTORY**  
**BUILDING AND STRUCTURES**  
 HIST-6 NEW 5/77

IDENTIFICATION	1. BUILDING NAME (Common) <span style="float: right;">(Historic)</span>		MARY READ SHERMAN HOUSE	
	2. TOWN CITY	VILLAGE	COUNTY	
	THOMPSON	THOMPSON	WINDHAM

3. STREET AND NUMBER (and/or location)			105/32-37
	1034 QUADDICK ROAD (18 QUADDICK RD.)			
	4. OWNER(S)		<input type="checkbox"/> Public <input checked="" type="checkbox"/> Private	
	DAVIS, RUTH M., BOX 79, THOMPSON, CT 06277

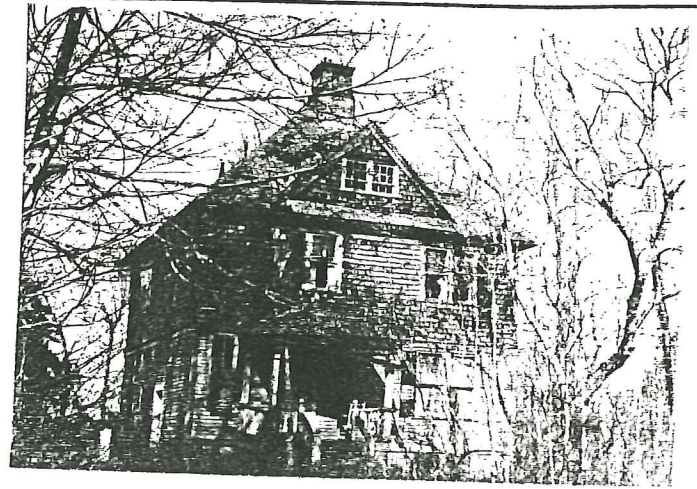
PHOTO	PHOTOGRAPHER Mark McDonough		DATE 1986
	VIEW NE	NEGATIVE ON FILE G13	
COMPILED BY	NAME Mark McDonough		DATE 1986
	ORGANIZATION Town of Thompson, Connecticut		
	ADDRESS

13. INTEGRITY (Location)		WHEN ?	(Alterations) IF YES, EXPLAIN	
<input checked="" type="checkbox"/> On original site	<input type="checkbox"/> Moved		<input checked="" type="checkbox"/> Yes <input type="checkbox"/> No extreme deterioration

Facade divided into two large bays. Clapboards on first floor, wood shingles on second; plain frieze and small flare between stories. Left entry under deteriorated hip-roofed portico on square posts with paneled bases. Portico has square balusters, molded rail, plain frieze, molded cornice. Wide heavy paneled door flanked by boarded sidelights. To left of entry, single narrow window. To right, paired windows and 1-over-4 sash. Second floor bays have paired 1-over-1. Large gabled roof dormer has paired 6-over-3. Steep pyramidal roof with central corbelled brick chimney. Left elevation has irregular fenestration, side entry. Right has one-story bay window.

Although the Sherman House may well be deteriorated beyond repair, it is significant as an attractive and unusually ornate example of early 20th-century vernacular building.
