**HISTORIC RESOURCES INVENTORY**  
**BUILDING AND STRUCTURES**  
 HIST-6 NEW 5/77

IDENTIFICATION	1. BUILDING NAME (Common) <span style="float: right;">(Historic)</span> JACOB TOURTELLOTTE HOUSE	
	2. TOWN CITY THOMPSON	VILLAGE EAST THOMPSON

3. STREET AND NUMBER (and/or location) 980 EAST THOMPSON ROAD (308 EAST THOMPSON RD.) 137/21-22	
	4. OWNER(S) WHITE, ELMER M. & GENEVA C., BOX 16, THOMPSON, CT 06277 <input type="checkbox"/> Public <input checked="" type="checkbox"/> Private

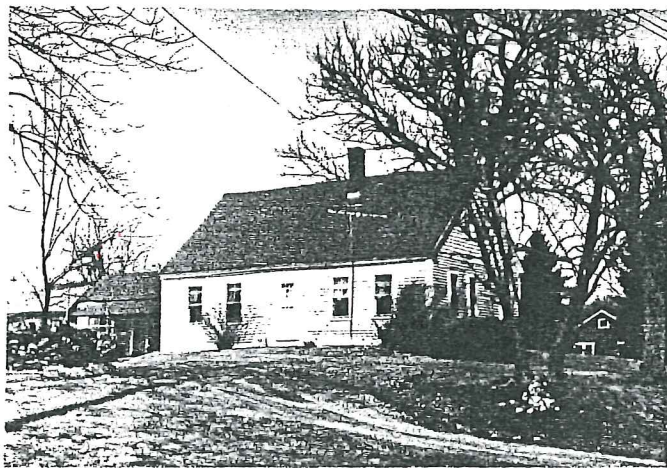
PHOTO	PHOTOGRAPHER Mark McDonough	DATE 1986
	VIEW NW	NEGATIVE ON FILE J6
COMPILED BY	NAME Mark McDonough	DATE 1986
	ORGANIZATION Town of Thompson, Connecticut	
	ADDRESS

11. NUMBER OF STORIES <span style="float: right;">APPROXIMATE DIMENSIONS</span> 1 1/2 <span style="float: right;">34' x 26'</span>	
	12. CONDITION (Structural) <span style="float: right;">(Exterior)</span> <input type="checkbox"/> Excellent <input checked="" type="checkbox"/> Good <input type="checkbox"/> Fair <input type="checkbox"/> Deteriorated <input type="checkbox"/> Excellent <input checked="" type="checkbox"/> Good <input type="checkbox"/> Fair <input type="checkbox"/> Deteriorated

13. INTEGRITY (Location) <span style="float: right;">WHEN? (Alterations) IF YES, EXPLAIN</span> <input checked="" type="checkbox"/> On original site <input type="checkbox"/> Moved <input checked="" type="checkbox"/> Yes <input type="checkbox"/> No <span style="float: right;">Victorian sash, shingles</span>
