HISTORIC RESOURCES INVENTORY
BUILDING AND STRUCTURES
 HIST-6 NEW 5/77

| IDENTIFICATION | 1. BUILDING NAME (Common) (Historic) | | OSCAR TOURTELLOTTE HOUSE | |
| | 67 MAIN STREET (86 MAIN ST.) | | | |

STATE OF CONNECTICUT
 CONNECTICUT HISTORICAL COMMISSION
 59 South Prospect Street, Hartford, Connecticut 06106
 HISTORIC RESOURCES INVENTORY FORM
 For Buildings and Structures

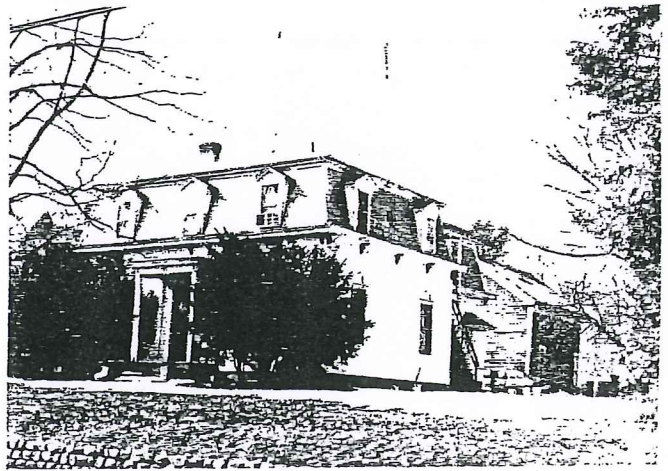
| | VIEW SW | NEGATIVE ON FILE C4 | |

17 OTHER NOTABLE FEATURES OF BUILDING OR SITE (interior and/or exterior)
 Three-bay facade with central entry. Deteriorated single-bay flat-roofed entry portico with square posts, plain frieze, small jigsawbrackets with turned pendants, molded cornice. Narrow double doors have single large lights over panels. Windows on all principal elevations have peaked hoods with applied floral decorations supported by scrolled jigsaw brackets with flutings, recessed panels, and carved half-orbs on leading edges. Brackets are pierced and connected by spiral-carved bar with plain bar with plain turned end pieces. Beneath bar, small dentil-like consoles. Sash generally 2-over-2. Mansard roof has plain frieze, molded cornice, brackets with incised vine motif. Roof has rosettes in colored hexagonal slate. Three gabled roof dormers have applied wooden decorations in peak.

Left elevation: bay window near front. Lower mansarded rear wing with somewhat simplified detail.
