**HISTORIC RESOURCES INVENTORY**  
**BUILDING AND STRUCTURES**  
 HIST-6 NEW 5/77

IDENTIFICATION	1. BUILDING NAME (Common) <span style="float: right;">(Historic)</span>	
	CORTTIS FARM	
	2. TOWN CITY	VILLAGE
	THOMPSON	CORTTIS FARM
	3. STREET AND NUMBER (and/or location)	
	152 CORTTIS ROAD (235 CORTTIS Rd.) 55 + 57/66-12

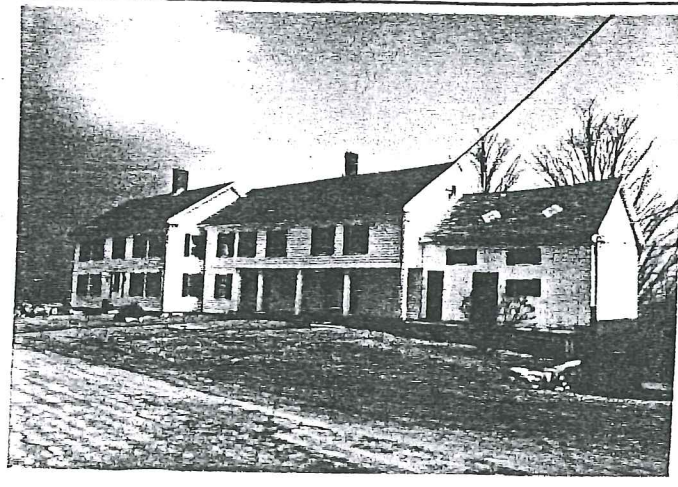
PHOTO	PHOTOGRAPHER Mark McDonough		DATE 1986
	VIEW N	NEGATIVE ON FILE H33	
COMPILED BY	NAME Mark McDonough		DATE 1986
	ORGANIZATION Town of Thompson, Connecticut		
	ADDRESS

Main (left) portion: five-bay facade, central entry. Window bays paired and offset with 2-over-2 sash. Entry has paneled surround with paneled corner blocks, old paneled wood door. Rectangular sidelights. Two story corner pilasters with pointed arched panels. Capitals have rows of small brackets. Wide plain architrave, wide plain frieze; molded cornice shows partial return.

Central brick chimney. To right: five-bay vernacular wing, framed out on second floor open porch on paneled square posts. Post detailing matches pilasters. Adjoining parallel shed/barn with patterned slate roof.
