HISTORIC RESOURCES INVENTORY
BUILDING AND STRUCTURES
 HIST-6 NEW 5, 77

IDENTIFICATION	1. BUILDING NAME (Common) (Historic) THE CASCADES INN THE CASCADES	
	2. TOWN CITY THOMPSON	VILLAGE MECHANICSVILLE
	3. STREET AND NUMBER (and/or location) 60-70 Old Route 12 (MAIN WING DEMOLISHED 1990) 67/96-10+9

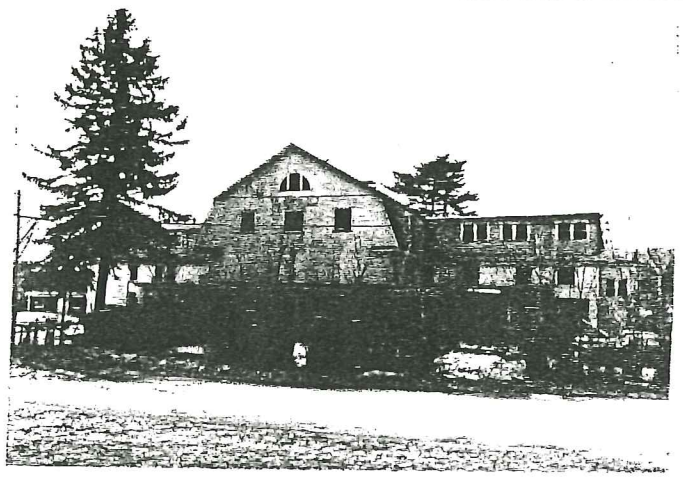
PHOTO	PHOTOGRAPHER Mark McDonough		DATE 1986
	VIEW SW	NEGATIVE ON FILE F26	
COMPILED BY	NAME Mark McDonough		DATE 1986
	ORGANIZATION Town of Thompson, Connecticut		
	ADDRESS		
20 SUBSEQUENT FIELD EVALUATION:

DESCRIPTION (Continued)	17 OTHER NOTABLE FEATURES OF BUILDING OR SITE (interior and/or exterior)
	<p>Main Wing: 2½ story; gambel roof, deteriorated. Tuscan-column porch wraps across inner portion of left and right wings. Porch has molded architrave, plain frieze, molded cornice with large mutules. Much sash has been destroyed. Remaining sash generally 8-over-8 & 10-over-10 in main wing, 6-over-6 in side wings. Semi-circular attic window has 3 part glazing molded keyblock surround.</p> <p>Right Wing: badly deteriorated, large shed-roofed, roof dormer.</p> <p>Left Wing: small entry porticoes with Tuscan-columns, everything else similar to right wing.</p>
