HISTORIC RESOURCES INVENTORY
BUILDING AND STRUCTURES
 HIST-6 NEW 5/77

IDENTIFICATION	1. BUILDING NAME (Common) (Historic)		COMINS HOUSE	
	2. TOWN CITY	VILLAGE	COUNTY	
	THOMPSON	THOMPSON	WINDHAM	
	3. STREET AND NUMBER (and/or location)			105/32-4
	1848 ROUTE 193 (365 THOMPSON RD.)

6. ACCESSIBILITY TO PUBLIC:		EXTERIOR VISIBLE FROM PUBLIC ROAD	INTERIOR ACCESSIBLE
<input checked="" type="checkbox"/> Yes <input type="checkbox"/> No		<input type="checkbox"/> Yes <input checked="" type="checkbox"/> No		
DESCRIPTION	7. STYLE OF BUILDING			DATE OF CONSTRUCTION
	Greek Revival			c. 1835

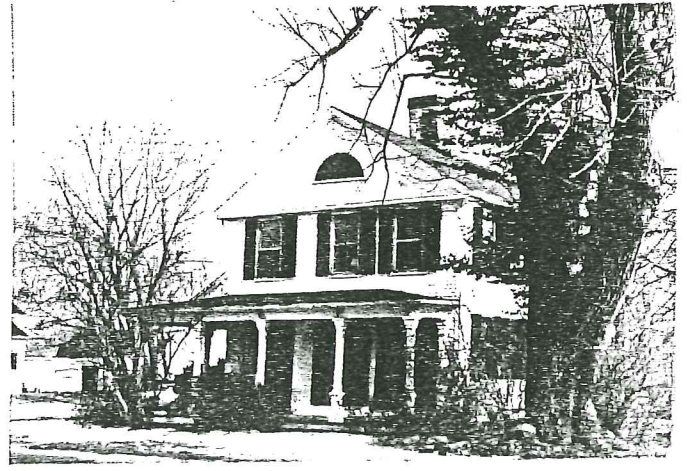
PHOTO	PHOTOGRAPHER Mark McDonough	DATE 1986
	VIEW NE	NEGATIVE ON FILE E16
COMPILED BY	NAME Mark McDonough	DATE 1986
	ORGANIZATION Town of Thompson, Connecticut	
	ADDRESS

11. NUMBER OF STORIES		APPROXIMATE DIMENSIONS		
2 1/2		23' X 32'		
12. CONDITION (Structural) (Exterior)				
<input type="checkbox"/> Excellent	<input checked="" type="checkbox"/> Good	<input type="checkbox"/> Fair	<input type="checkbox"/> Deteriorated	
<input type="checkbox"/> Excellent	<input checked="" type="checkbox"/> Good	<input type="checkbox"/> Fair	<input type="checkbox"/> Deteriorated
