**HISTORIC RESOURCES INVENTORY**  
**BUILDING AND STRUCTURES**  
 HIST-6 NEW 5/77

1. BUILDING NAME (Common) <span style="float: right;">(Historic)</span>	
TALCOTT CROSBY HOUSE (1)	
2. TOWN CITY THOMPSON	VILLAGE THOMPSON
COUNTY WINDHAM	
3. STREET AND NUMBER (and/or location) 1815 ROUTE 193 (382 THOMPSON RD.) 105/40-12

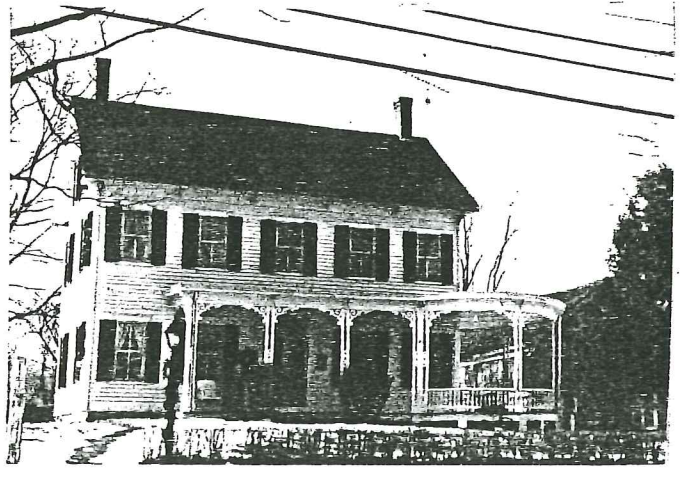
PHOTO	PHOTOGRAPHER Mark McDonough	DATE 1986
	VIEW NW	NEGATIVE ON FILE E19
COMPILED BY	NAME Mark McDonough	DATE 1986
	ORGANIZATION Town of Thompson, Connecticut	
	ADDRESS

11. NUMBER OF STORIES 2 1/2	APPROXIMATE DIMENSIONS 35' x 20' (main part)
12. CONDITION (Structural) <span style="float: right;">(Exterior)</span>	
<input type="checkbox"/> Excellent <input checked="" type="checkbox"/> Good <input type="checkbox"/> Fair <input type="checkbox"/> Deteriorated	<input type="checkbox"/> Excellent <input checked="" type="checkbox"/> Good <input type="checkbox"/> Fair <input type="checkbox"/> Deteriorated

Five-bay facade, central entry. Sash generally 2-over-2. Windows have plain friezes, flat molded caps. Entry in large round arched opening with glazed transom. Molded entry surround, modern metal storm doors.

Porch: covers bays two through five, extends at right to form rounded pavillion. Lattice posts with intricate decorative panels. Large and extravagantly scrolled jigsawn brackets. Turned balusters, molded rail. House has plain frieze with paired jigsawn brackets; molded cornice shows partial return. Side elevations plain.
