HISTORIC RESOURCES INVENTORY
BUILDING AND STRUCTURES
 HIST-6 NEW 5/77

| ALMON E. WOODARD HOUSE | | | |
| 773 EAST THOMPSON ROAD (415 EAST THOMPSON RD.) | | 135/7-5 (1) | |

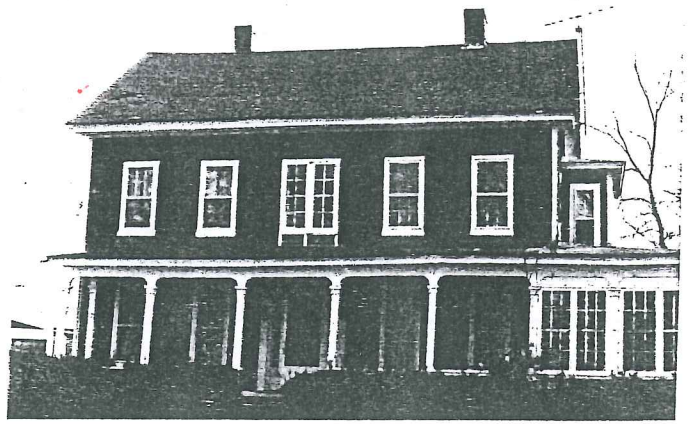
| | VIEW S | NEGATIVE ON FILE J8 | |

| 12. CONDITION (Structural) (Exterior) | |
| <input type="checkbox"/> Excellent <input type="checkbox"/> Good <input checked="" type="checkbox"/> Fair <input type="checkbox"/> Deteriorated | <input type="checkbox"/> Excellent <input type="checkbox"/> Good <input checked="" type="checkbox"/> Fair <input type="checkbox"/> Deteriorated |
| <input checked="" type="checkbox"/> On original site <input type="checkbox"/> Moved | <input checked="" type="checkbox"/> Yes <input type="checkbox"/> No Considerable shingles, porch, etc. |

Five-bay facade, central entry. Heavy paneled wood door, narrow rectangular sidelights flanked by slender pilasters with molded capitals. Two pane rectangular glazed transom above. Sash generally 6-over-6. Double glass doors have entry.

One story full width porch on square chamfered Italianate posts, glassed-in at right. Shingled railing. Overhanging eaves. Molded cornice shows partial return.

Twin brick chimneys. Left elevation has Palladian attic window.

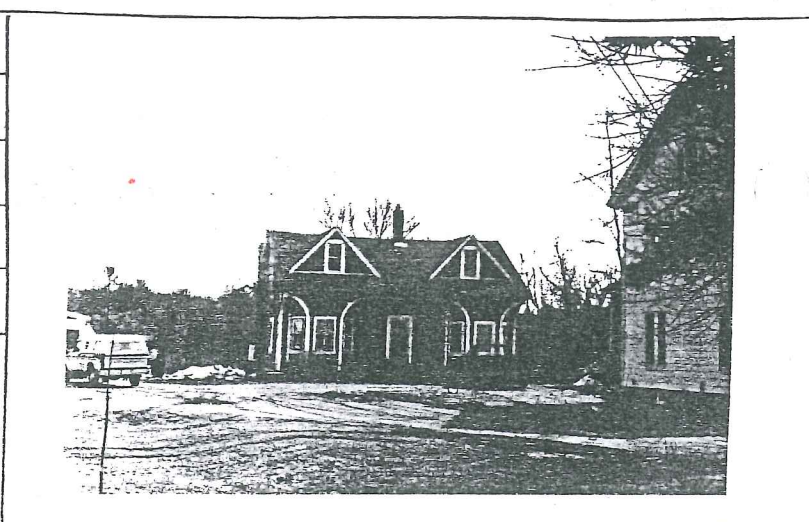
| | VIEW S | NEGATIVE ON FILE J9 | |

| | 12. CONDITION (Structural) _____ (Exterior) _____ <input type="checkbox"/> Excellent <input checked="" type="checkbox"/> Good <input type="checkbox"/> Fair <input type="checkbox"/> Deteriorated <input type="checkbox"/> Excellent <input checked="" type="checkbox"/> Good <input type="checkbox"/> Fair <input type="checkbox"/> Deteriorated | |
| | 13. INTEGRITY (Location) _____ WHEN? _____ (Alterations) _____ IF YES, EXPLAIN _____ <input checked="" type="checkbox"/> On original site <input type="checkbox"/> Moved <input checked="" type="checkbox"/> Yes <input type="checkbox"/> No Later ext. chimney | |

Three-bay facade. Central entry has wood door with single large pane over panels. Facade has staggered-butt shingles.

Left and right bay windows with plain corner boards. Corner boards flare to form shallow round arched opening over entry; they meet flared main corner boards to form pointed arched recesses at left and right corners. Large gabled roof dormers. Old central brick chimney.
