**HISTORIC RESOURCES INVENTORY
BUILDING AND STRUCTURES**

IDENTIFICATION	1. BUILDING NAME (Common) (Historic)		SAMUEL & MALVINA LaROSE HOUSE		
	2. TOWN CITY THOMPSON		VILLAGE NORTH GROSVENORDALE	COUNTY WINDHAM

IDENTIFICATION	1. BUILDING NAME (Common) (Historic)		LENGUES LaCHANCE TENEMENT		
	2. TOWN CITY	VILLAGE	COUNTY		
	THOMPSON	NORTH GROSVENORDALE	WINDHAM		
	3. STREET AND NUMBER (and/or location)		169/91-20		
	150 MAIN STREET (DEMOLISHED - 1987)

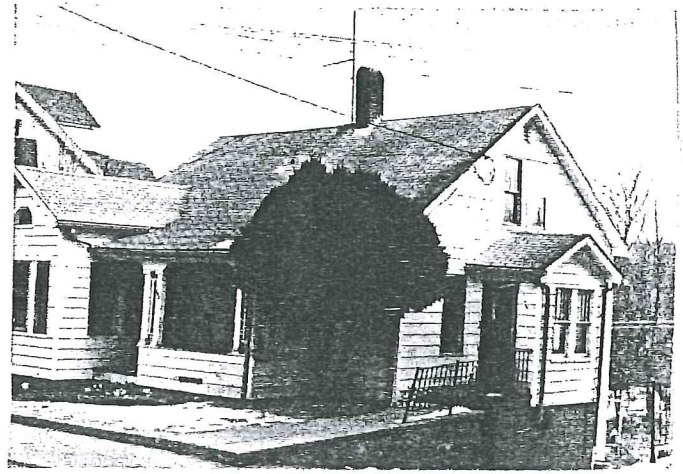
11. NUMBER OF STORIES 1 1/2		APPROXIMATE DIMENSIONS 30' X 26'			
12. CONDITION (Structural) (Exterior)					
<input type="checkbox"/> Excellent <input checked="" type="checkbox"/> Good <input type="checkbox"/> Fair <input type="checkbox"/> Deteriorated <input type="checkbox"/> Excellent <input checked="" type="checkbox"/> Good <input type="checkbox"/> Fair <input type="checkbox"/> Deteriorated

13. INTEGRITY (Location)		WHEN ?	(Alterations)	IF YES, EXPLAIN	
<input checked="" type="checkbox"/> On original site <input type="checkbox"/> Moved			<input checked="" type="checkbox"/> Yes <input type="checkbox"/> No	siding, storm sash

Main portion of house is a simple gabled structure, oriented ridge-parallel-to-street. Sash generally has four vertically oriented panes in the upper sash, one pane in the lower. Small front-facing gabled wing at left-front corner has radial-glazed semi-circular attic window. Small porch at center shelters entry, is formed by extension of main roofline. Wood door has modified border-pane glazing. Porch has paired square posts, plain frieze, shallow round-arched openings.

Right elevation has gabled vestibule with side entry.

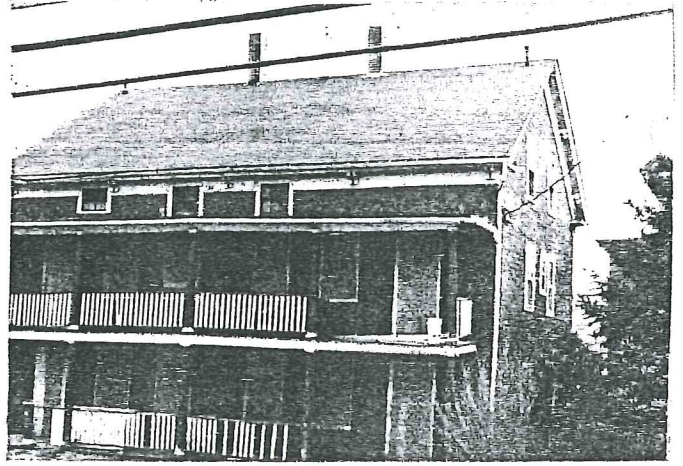
11. NUMBER OF STORIES		APPROXIMATE DIMENSIONS			
2 1/2		42' X 32'			
12. CONDITION (Structural)		(Exterior)			
<input type="checkbox"/> Excellent	<input type="checkbox"/> Good	<input checked="" type="checkbox"/> Fair	<input type="checkbox"/> Deteriorated		
<input type="checkbox"/> Excellent	<input type="checkbox"/> Good	<input type="checkbox"/> Fair	<input checked="" type="checkbox"/> Deteriorated

13. INTEGRITY (Location)		WHEN ?	(Alterations) IF YES, EXPLAIN		
<input checked="" type="checkbox"/> On original site	<input type="checkbox"/> Moved		<input checked="" type="checkbox"/> Yes <input type="checkbox"/> No See #17

Six-bay facade, entries in one and six. Doors are Victorian with twin rectangular lights over panels with heavy molded surrounds. Sash is 2-over-2. (Both doors and windows have recently been boarded).

Two-story flat-roofed porch has Tuscan-column, molded rail, slat railing. Porch roof has exposed rafters with scalloped ends. Small frieze-band windows above porch roof. Main cornice has plain frieze, paired jigsaw brackets, molded cornice, partial return.

<input type="checkbox"/> None known	<input type="checkbox"/> Highways	<input type="checkbox"/> Vandalism	<input type="checkbox"/> Developers	<input type="checkbox"/> Other _____
<input type="checkbox"/> Renewal	<input type="checkbox"/> Private	<input checked="" type="checkbox"/> Deterioration	<input type="checkbox"/> Zoning	<input type="checkbox"/> Explanation _____
