HISTORIC RESOURCES INVENTORY  
BUILDING AND STRUCTURES  
HIST-6 NEW 5/77

1. BUILDING NAME (Common)		(Historic)	
THOMPSON		THOMAS ELLIOTT FARM	
2. TOWN CITY	VILLAGE	COUNTY	
THOMPSON	WEST THOMPSON	WINDHAM	
3. STREET AND NUMBER (and/or location)		65/101-9B	
56 WEST THOMPSON ROAD (30 W. THOMPSON RD.)			
4. OWNER(S)			
FAUCHER, RAYMOND P., SR. & BARBARA JANE, RR#1, N. GROS., CT 06255 <input type="checkbox"/> Public <input checked="" type="checkbox"/> Private			
5. USE (Present)		(Historic)	
Residence		Residence	
6. ACCESSIBILITY TO PUBLIC:		IF YES, EXPLAIN	
EXTERIOR VISIBLE FROM PUBLIC ROAD <input checked="" type="checkbox"/> Yes <input type="checkbox"/> No		INTERIOR ACCESSIBLE <input type="checkbox"/> Yes <input checked="" type="checkbox"/> No	
7. STYLE OF BUILDING		DATE OF CONSTRUCTION	
Federal		c. 1815

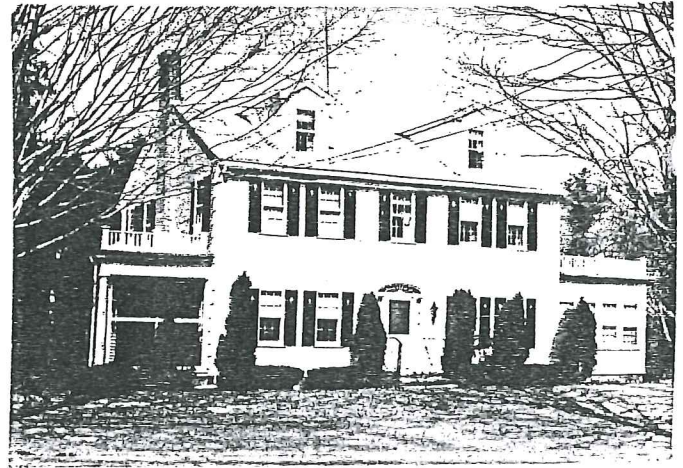
PHOTO	PHOTOGRAPHER Mark McDonough		DATE 1986
	VIEW NE	NEGATIVE ON FILE K9	
COMPILED BY	NAME Mark McDonough		DATE 1986
	ORGANIZATION Town of Thompson, Connecticut		
	ADDRESS

Five-bay facade, central entry. Recent 6-over-6 sash. Window bays paired and offset towards corners of house. Entry has slender fluted pilasters, rectangular sidelights, semi-elliptical fanlight with molded surround (much recent fabric). Wood quoins, brick endwalls.

Architrave has key molding, spiral bed molding; molded cornice shows partial return. Left elevation has later exterior brick chimney, Tuscan columned screened-in one story porch c. 1915. Right has framed-in one story porch with balustrade.
