**HISTORIC RESOURCES INVENTORY**  
**BUILDING AND STRUCTURES**  
 HIST-6 NEW 5/77

IDENTIFICATION	1. BUILDING NAME (Common) <i>(Historic)</i>		CENTECH METAL PRODUCTS		MECHANICSVILLE SCHOOL	
	2. TOWN CITY		VILLAGE		COUNTY	
	THOMPSON		MECHANICSVILLE		WINDHAM

3. STREET AND NUMBER (and/or location)					
	2386 ROUTE 12		(227 RIVERSIDE DR.)		67/52-4	
	4. OWNER(S)					
	OLEKSIAK, JOSEPH & LEAH A., RRI, N. GROSVENORDALE, CT 06255				<input type="checkbox"/> Public <input checked="" type="checkbox"/> Private

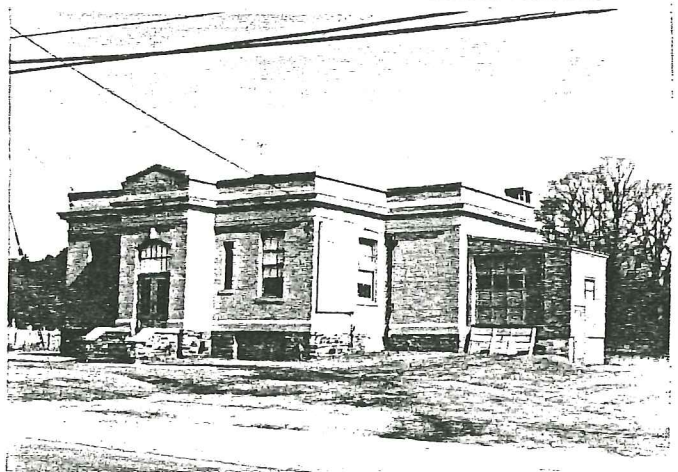
PHOTO	PHOTOGRAPHER Mark McDonough		DATE 1986
	VIEW NW	NEGATIVE ON FILE F19	
COMPILED BY	NAME Mark McDonough		DATE 1986
	ORGANIZATION Town of Thompson, Connecticut		
	ADDRESS

11. NUMBER OF STORIES		APPROXIMATE DIMENSIONS				
1		41' x 38'				
12. CONDITION (Structural) <i>(Exterior)</i>						
<input type="checkbox"/> Excellent		<input checked="" type="checkbox"/> Good		<input type="checkbox"/> Fair		<input type="checkbox"/> Deteriorated
						<input type="checkbox"/> Excellent <input checked="" type="checkbox"/> Good <input type="checkbox"/> Fair <input type="checkbox"/> Deteriorated

13. INTEGRITY (Location) WHEN? (Alterations) IF YES, EXPLAIN						
<input checked="" type="checkbox"/> On original site		<input type="checkbox"/> Moved		<input checked="" type="checkbox"/> Yes <input type="checkbox"/> No		Loading dock added to west elevation
