**Thompson  
Historical  
Society**

Historic Property Name (if applicable): William H. Mason House

## **THOMPSON HISTORICAL SOCIETY HISTORIC PLACE DECRIPTION**

HISTORIC RESOURCES INVENTORY FORM

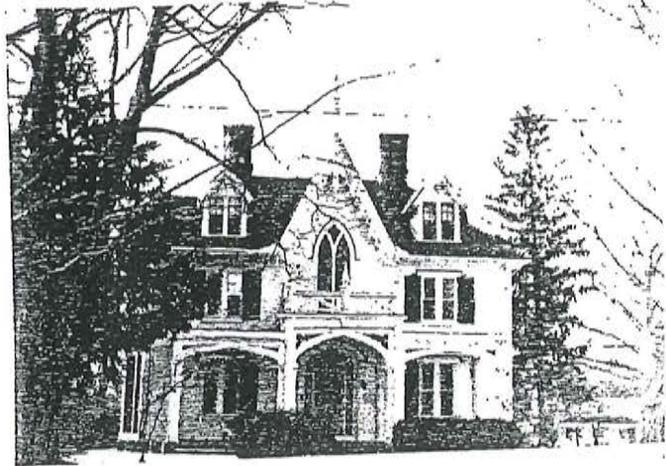
PHOTO	PHOTOGRAPHER Mark McDonough		DATE 1986
	VIEW SW	NEGATIVE ON FILE E12	
COMPILED BY	NAME Mark McDonough		DATE 1986
	ORGANIZATION Town of Thompson, Connecticut		
	ADDRESS

11. NUMBER OF STORIES		APPROXIMATE DIMENSIONS			
2 1/2		45' X 44'			
12. CONDITION (Structural)		(Exterior)			
<input type="checkbox"/> Excellent <input checked="" type="checkbox"/> Good <input type="checkbox"/> Fair <input type="checkbox"/> Deteriorated		<input type="checkbox"/> Excellent <input checked="" type="checkbox"/> Good <input type="checkbox"/> Fair <input type="checkbox"/> Deteriorated

17 OTHER NOTABLE FEATURES OF BUILDING OR SITE (interior and/or exterior)  
 Three-bay facade, central entry. Principal windows on first and second floors have paired 4-over-4 sash, molded surrounds, rectangular drip moldings. Entry has lancet sidelights, pointed-arched stained-glass transom, pointed-arched drip molding. Door has twin lancet panels. Above entry is steep-gabled wall dormer with stained-glass lancet windows, elaborate scalloped vergeboard, carved floral panels and medallions in peak. Large finial with floral carvings, turned pendant below. Full-width flat-roofed porch has posts carved to resemble grouped slender round columns with annular rings. Engaged posts flank entry. No porch rail, brackets form shallow pointed-arched openings with trefoil-motif spandrels.

Central bay is higher, has timber balustrade with trefoil openings, paneled newel posts with finials. House has two-story corner pilasters in the form of engaged octagonal columns. Overhanging eaves, molded cornice. Two steep-gabled roof dormers with paired 4-over-4 sash, scaled-down vergeboards and finials similar to main peak.

17) Two large corbelled brick chimneys. Side elevations have one-story bay window with lancet windows, single roof dormers. Rear elevation has simplified wall dormer, small one-story parallel wing.

Medieval detailing, generally rendered in wood. Typical features present here include the porch post and brackets, the centered wall dormer with vergeboard and finial, the lancet windows and drip moldings, and the steeply pitched gables.
