**HISTORIC RESOURCES INVENTORY**  
**BUILDING AND STRUCTURES**  
 HIST-6 NEW 5/77

1. BUILDING NAME (Common) <span style="float: right;">(Historic)</span>	
DARIUS DWIGHT HOUSE	
2. TOWN CITY	VILLAGE
THOMPSON	THOMPSON
3. STREET AND NUMBER (and/or location)	
1008 QUADDICK ROAD (32 QUADDICK RD.)	
105/32-35	
4. OWNER(S)	
VAN HOOGSTRA滕, JAN S. & ELEANOR C. THOMPSON, CT 06277	
5. USE (Present) <span style="float: right;">(Historic)</span>	
Residence <span style="float: right;">Residence</span>	
6. ACCESSIBILITY TO PUBLIC:	IF YES, EXPLAIN
<input checked="" type="checkbox"/> Yes <input type="checkbox"/> No <input type="checkbox"/> Yes <input checked="" type="checkbox"/> No

7. STYLE OF BUILDING	DATE OF CONSTRUCTION
Vernacular	late 18th century

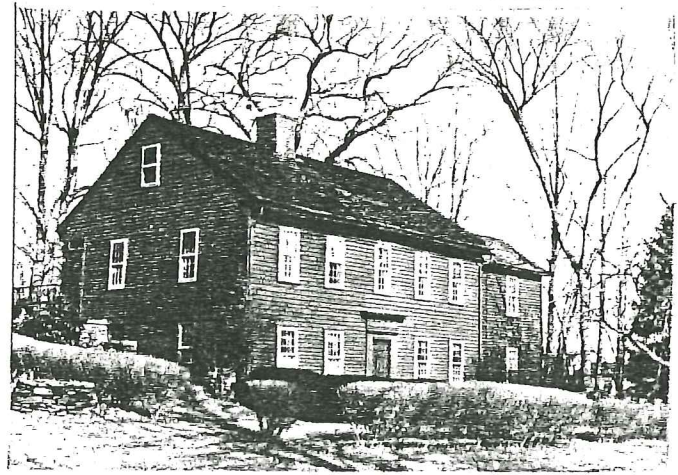
PHOTO	PHOTOGRAPHER Mark McDonough		DATE 1986
	VIEW NE	NEGATIVE ON FILE G15	
COMPILED BY	NAME Mark McDonough		DATE 1986
	ORGANIZATION TOWN OF THOMPSON, CONNECTICUT		
	ADDRESS

12. CONDITION (Structural) <span style="float: right;">(Exterior)</span>	
<input type="checkbox"/> Excellent <input checked="" type="checkbox"/> Good <input type="checkbox"/> Fair <input type="checkbox"/> Deteriorated	<input type="checkbox"/> Excellent <input checked="" type="checkbox"/> Good <input type="checkbox"/> Fair <input type="checkbox"/> Deteriorated

13. INTEGRITY (Location)	WHEN ?	(Alterations)	IF YES, EXPLAIN
<input checked="" type="checkbox"/> On original site <input type="checkbox"/> Moved		<input checked="" type="checkbox"/> Yes <input type="checkbox"/> No	RECENT SASH

Five-bay facade, central entry, recent 12-over-12 sash. Left and right window bays paired slightly and offset towards corners of house. Entry has recent paneled door, recent molded surround. Above, wide plain lintel with central scalloped molding is old or original. Flat-molded cap has small flared brackets, also old or original. Wide frieze with moldings at top and bottom, molded cornice, partial return.

House has beaded corner boards, central brick chimney. Right elevation has slightly lower parallel one-bay extension.
