HISTORIC RESOURCES INVENTORY
BUILDING AND STRUCTURES
 HIST-6 NEW 5/77

1. BUILDING NAME (Common)		(Historic)	
THOMPSON		REVEREND EDWARD P. BORDEN HOUSE	
2. TOWN CITY	VILLAGE	COUNTY	
THOMPSON	THOMPSON	WINDHAM	
3. STREET AND NUMBER (and/or location)		105/32-36	
1020 QUADDICK ROAD (24 QUADDICK RD.)

CONTINUATION SHEET #19 REVEREND EDWARD P. BORDEN HOUSE
 Item number: _____ Date: _____

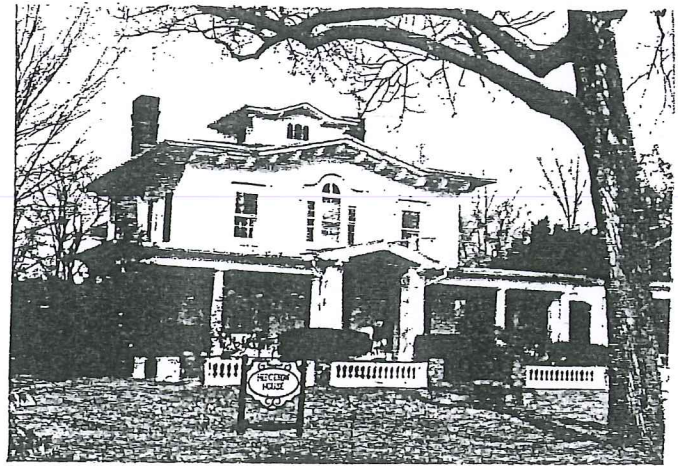
PHOTO	PHOTOGRAPHER Mark McDonough	DATE 1986
	VIEW NE	NEGATIVE ON FILE G14
COMPILED BY	NAME Mark McDonough	DATE 1986
	ORGANIZATION Town of Thompson, Connecticut	
	ADDRESS

11. NUMBER OF STORIES		APPROXIMATE DIMENSIONS	
2 1/2		40' x 31' (main part)	
12. CONDITION (Structural)			
<input type="checkbox"/> Excellent	<input checked="" type="checkbox"/> Good	<input type="checkbox"/> Fair	<input type="checkbox"/> Deteriorated
(Exterior)			
<input type="checkbox"/> Excellent	<input checked="" type="checkbox"/> Good	<input type="checkbox"/> Fair	<input type="checkbox"/> Deteriorated

17 OTHER NOTABLE FEATURES OF BUILDING OR SITE (interior and/or exterior)
 Three-bay facade, central entry. Door has very large light over panels. Stained glass sidelights, segmental arched stained glass transom. To left and right of entry, oversized windows with heavy molded segmental arched surrounds, six-pane sash.
 One story flat roofed porch with shallow gable centered on entry. Porch wraps left to meet one story bay window, extends to right to form port cochere. Porch has fieldstone apron, turned balusters, molded rail, fluted Doric columns. Plain frieze with central molding, molded cornice on large brackets. Entry gable framed by large battered paneled columns.
 On second floor, 6-over-6 sash. Flat molded hoods on heavy consoles left and right. Central Palladian style window with semi-circular glazed transom, round arched hood on heavy console
 Overhanging eaves on large purlin-like brackets. Nearly flat roof with shallow gable at center. Square cupola has similar eave and roof detailing; triple round arched windows with molded surround. Very large corbelled brick chimneys flank cupola; left chimney is exterior, cuts through eaves.
