HISTORIC RESOURCES INVENTORY
BUILDING AND STRUCTURES
HIST-6 NEW 5/77

1. BUILDING NAME (Common)	(Historic)		
2. TOWN CITY THOMPSON	VILLAGE THOMPSON	COUNTY WINDHAM	
3. STREET AND NUMBER (and/or location) 1044 QUADDICK ROAD (14 QUADDICK Rd.)	105/32-38

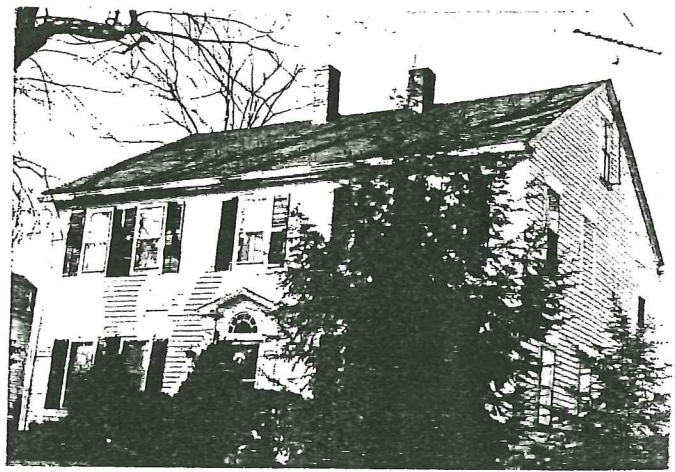
PHOTO	PHOTOGRAPHER Mark McDonough		DATE 1986
	VIEW NW	NEGATIVE ON FILE G12	
COMPILED BY	NAME Mark McDonough		DATE 1986
	ORGANIZATION Town of Thompson, Connecticut		
	ADDRESS

11. NUMBER OF STORIES 2 1/2	APPROXIMATE DIMENSIONS 36' x 30'		
12. CONDITION (Structural) (Exterior)			
<input type="checkbox"/> Excellent <input checked="" type="checkbox"/> Good <input type="checkbox"/> Fair <input type="checkbox"/> Deteriorated <input type="checkbox"/> Excellent <input checked="" type="checkbox"/> Good <input type="checkbox"/> Fair <input type="checkbox"/> Deteriorated

DESCRIPTION (Continued)	17 OTHER NOTABLE FEATURES OF BUILDING OR SITE (interior and/or exterior)
	<p>Five-bay facade, central entry. Windows paired and offset towards corners of house. Sash generally 2-over-2. First floor facade windows and all side elevation windows have splayed wood lintels. Second floor facade windows located high under eaves.</p> <p>Entry: heavy paneled wood door, fluted entry pilasters, open pediment hood with dentils, cut to plumb rakes. Semi-circular fanlight (later glazing). Left elevation has 12-over-12 attic sash, oriel bay window on first floor. One-and-one-half-story plain cross-gabled rear extension.</p>
