HISTORIC RESOURCES INVENTORY
BUILDING AND STRUCTURES

IDENTIFICATION	1. BUILDING NAME (Common) _____ (Historic) _____	
	2. TOWN CITY THOMPSON	VILLAGE THOMPSON
	3. STREET AND NUMBER (and/or location) 975 QUADDICK ROAD (47 QUADDICK RD.) 105/33-10

7. STYLE OF BUILDING Vernacular	
	DATE OF CONSTRUCTION c. 1815	
	8. MATERIAL(S) (Indicate use or location when appropriate)	
	<input checked="" type="checkbox"/> Clapboard <input type="checkbox"/> Asbestos Siding <input checked="" type="checkbox"/> Chimneys <input type="checkbox"/> Other (Specify) _____ <input type="checkbox"/> Wood Shingle <input type="checkbox"/> Asphalt Siding <input checked="" type="checkbox"/> Brick <input type="checkbox"/> Fieldstone Foundation <input type="checkbox"/> Board & Batten <input type="checkbox"/> Stucco <input type="checkbox"/> Cobblestone <input type="checkbox"/> Aluminum Siding <input type="checkbox"/> Concrete Type: _____ <input type="checkbox"/> Cut stone Type: _____

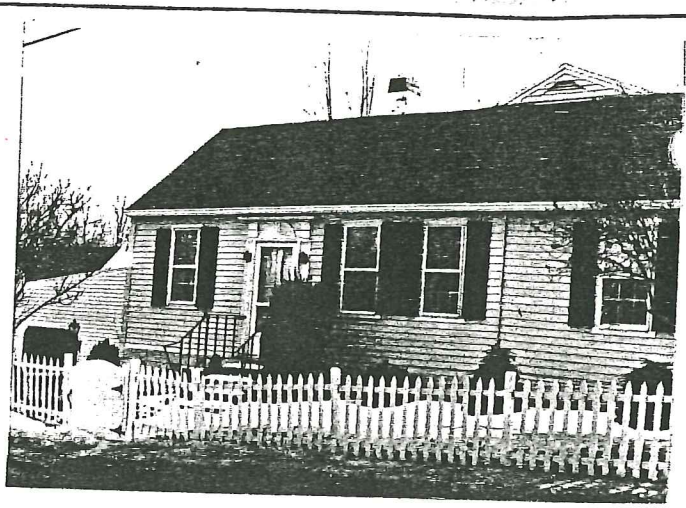
PHOTO	PHOTOGRAPHER Mark McDonough		DATE 1986
	VIEW SE	NEGATIVE ON FILE G18	
COMPILED BY	NAME Mark McDonough		DATE 1986
	ORGANIZATION Town of Thompson, Connecticut		
	ADDRESS

Four-bay facade, entry in second bay. Single-bay flush extension to right, cross-gabled rear extension.

Attached garage downslope to left. Walls considerably out of plumb. Entry has old paneled door, pilasters with molded edges, plain capitals with central molding. Semi-circular wooden fan above, flat molded cup.

Historically, the house is significant as part of a large and well-preserved assemblage of 18th and 19th century buildings surrounding the village center of Thompson Hill. The building's original appearance has been much altered by subsequent additions, but the out-of-plumb walls, ridge-parallel-to-street orientation, and simple rectangular plan testify to its early 19th-century origin; most exterior fabric is much later.
