**HISTORIC RESOURCES INVENTORY**  
**BUILDING AND STRUCTURES**  
 HIST-6 NEW 5-77

1. BUILDING NAME (Common)		(Historic)	
THOMPSON		THE JAMES AND NANCY CRUFF FARM	
2. TOWN CITY	VILLAGE	COUNTY	
THOMPSON	THOMPSON	WINDHAM	
3. STREET AND NUMBER (and/or location)		105/33-20 (2)	
278 CHASE ROAD (143 CHASE RD.)			
4. OWNER(S)		<input type="checkbox"/> Public	<input checked="" type="checkbox"/> Private
BROUGHTON, JULIA A., BOX 3441, GROTON, CT 06340			
5. USE (Present)		(Historic)	
Residence		Residence	
6. ACCESSIBILITY TO PUBLIC:	EXTERIOR VISIBLE FROM PUBLIC ROAD	INTERIOR ACCESSIBLE	IF YES, EXPLAIN
<input checked="" type="checkbox"/> Yes <input type="checkbox"/> No	<input type="checkbox"/> Yes <input checked="" type="checkbox"/> No

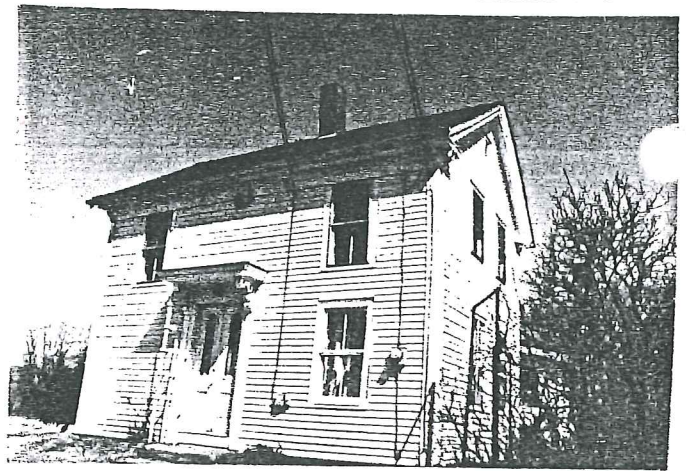
PHOTO	PHOTOGRAPHER Mark McDonough	DATE 1986
	VIEW NW	NEGATIVE ON FILE L18
COMPILED BY	NAME Mark McDonough	DATE 1986
	ORGANIZATION Town of Thompson, Connecticut	
	ADDRESS

11. NUMBER OF STORIES		APPROXIMATE DIMENSIONS	
2 1/2		22' x 16' (main part); 22' x 65' (overall)	
12. CONDITION (Structural)		(Exterior)	
<input type="checkbox"/> Excellent <input checked="" type="checkbox"/> Good <input type="checkbox"/> Fair <input type="checkbox"/> Deteriorated	<input type="checkbox"/> Excellent <input checked="" type="checkbox"/> Good <input type="checkbox"/> Fair <input type="checkbox"/> Deteriorated

13. INTEGRITY (Location)		WHEN? (Alterations) IF YES, EXPLAIN	
<input checked="" type="checkbox"/> On original site <input type="checkbox"/> Moved	<input checked="" type="checkbox"/> Yes <input type="checkbox"/> No	LATER SIDING

Three-bay facade, central entry. Blind bay to left of entry. Blind second floor bay above entry. Double wooden doors with round arched lights over panels. Narrow plain entry pilasters, flat molded cap on jigsawn consoles with turned pendants, scroll-cut edges. Prominent plain corner boards (suggesting pilasters).

Wide plain frieze, low relief dentils and paired jigsawn brackets beneath molded cornice. Cornice shows partial return across gable ends.

Left elevation has rectangular bay window with denticular molded cornice. Large two story cross gabled rear wing; side entry with detailing similar to front.
