HISTORIC RESOURCES INVENTORY
BUILDING AND STRUCTURES
 HIST-6 NEW 5/77

IDENTIFICATION	1. BUILDING NAME (Common) _____ (Historic) _____	
	2. TOWN CITY THOMPSON	VILLAGE THOMPSON
	3. STREET AND NUMBER (and/or location) 104 CHASE ROAD <i>47 Chase Rd</i> 105/33-28

7. STYLE OF BUILDING Vernacular	
	8. MATERIAL(S) (Indicate use or location when appropriate)	
	9. STRUCTURAL SYSTEM	
	10. ROOF (Type)	
DESCRIPTION	11. NUMBER OF STORIES 2 1/2

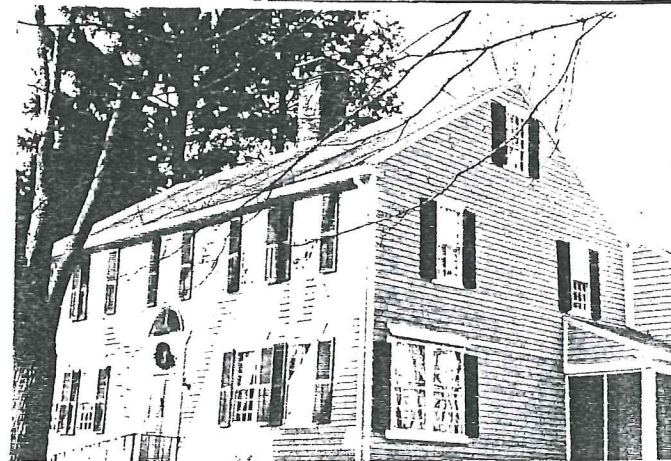
PHOTO	PHOTOGRAPHER Mark McDonough		DATE 1986
	VIEW NW	NEGATIVE ON FILE E31	
COMPILED BY	NAME Mark McDonough		DATE 1986
	ORGANIZATION Town of Thompson, Connecticut		
	ADDRESS

Five-bay facade, central entry. Window bays paired and offset towards corners of house. Sash 12-over-12. Second floor windows high under eaves. First floor windows and entry have splayed wood lintels.

Entry has old heavy paneled door, boarded up rectangular glazed transom. New (1986) semi-circular clapboard fan over entry. Some old beaded corner board. Molded cornice shows partial return. Central brick chimney. Most exterior cladding 1985. Old cross-gabled rear wing.
