HISTORIC RESOURCES INVENTORY
BUILDING AND STRUCTURES
 HIST-6 NEW 5/77

IDENTIFICATION	1. BUILDING NAME (Common) _____ (Historic) _____	
	2. TOWN CITY THOMPSON	VILLAGE THOMPSON
	3. STREET AND NUMBER (and/or location) 1043 QUADDICK ROAD (11 QUADDICK RD.) 105/33-7

5. USE (Present) _____ (Historic) _____ Residence Residence	
	6. ACCESSIBILITY TO PUBLIC: <input checked="" type="checkbox"/> Yes <input type="checkbox"/> No EXTERIOR VISIBLE FROM PUBLIC ROAD <input type="checkbox"/> Yes <input checked="" type="checkbox"/> No INTERIOR ACCESSIBLE <input type="checkbox"/> Yes <input checked="" type="checkbox"/> No IF YES, EXPLAIN _____	
DESCRIPTION	7. STYLE OF BUILDING Federal/Greek Revival	
	DATE OF CONSTRUCTION c. 1830

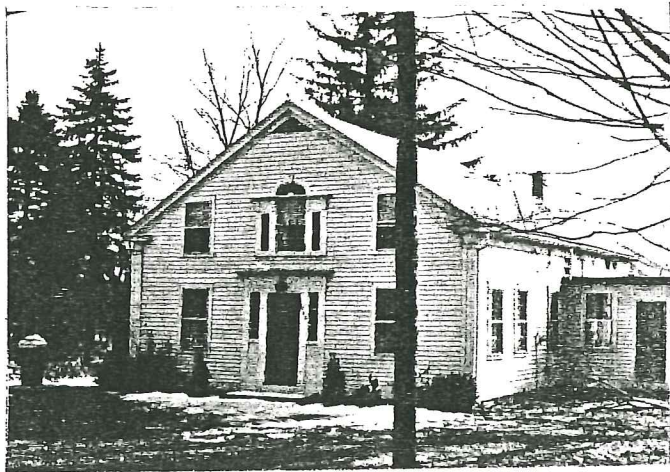
PHOTO	PHOTOGRAPHER Mark McDonough	DATE 1986
	VIEW SE	NEGATIVE ON FILE G20
COMPILED BY	NAME Mark McDonough	DATE 1986
	ORGANIZATION Town of Thompson, Connecticut	
	ADDRESS

11. NUMBER OF STORIES 1 1/2		
APPROXIMATE DIMENSIONS 30' X 30' (main part)		
12. CONDITION (Structural) _____ (Exterior) _____ <input type="checkbox"/> Excellent <input checked="" type="checkbox"/> Good <input type="checkbox"/> Fair <input type="checkbox"/> Deteriorated <input type="checkbox"/> Excellent <input checked="" type="checkbox"/> Good <input type="checkbox"/> Fair <input type="checkbox"/> Deteriorated

Three-bay facade, central entry flanked by sidelights. Plain surround under flat molded cap. Heavy-paneled door. Sash generally 6-over-6. Above entry, Palladian-styled window: 6-over-6 flanked by shutter-like panels topped by clapboard sunburst with molded surround, fluted keyblock. Paneled corner pilasters, plain frieze, molded cornice shows partial return. Right elevation has small flat-roofed bay at rear, frieze-band windows. Left elevation has Victorian bay window with bracketed cornice.

To rear, house adjoins shed/barn (now garage).
