HISTORIC RESOURCES INVENTORY  
BUILDING AND STRUCTURES

IDENTIFICATION	1. BUILDING NAME (Common) <span style="float:right">(Historic)</span>		HENRY FOUNTAIN HOUSE		
	2. TOWN CITY	VILLAGE	COUNTY		
	THOMPSON	THOMPSON	WINDHAM

3. STREET AND NUMBER (and/or location)		105/34-14		
	117 CHASE ROAD (54 CHASE RD.)				
	4. OWNER(S)	BARKS, RONALD E. & RUTH, THOMPSON, CT 06277		<input type="checkbox"/> Public	<input checked="" type="checkbox"/> Private
DESCRIPTION	5. USE (Present) <span style="float:right">(Historic)</span>		Residence		
	Residence		Residence

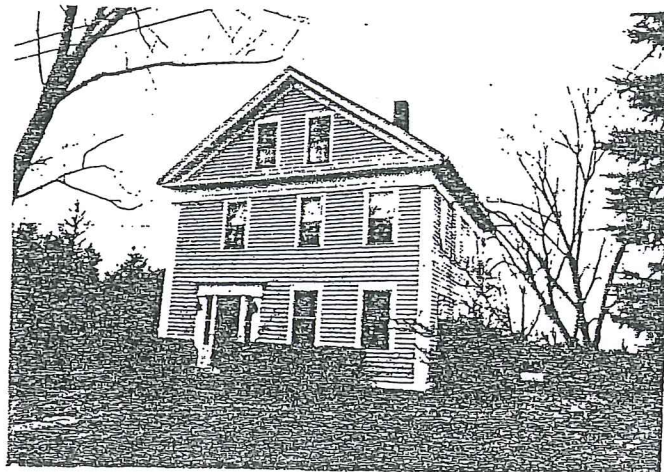
PHOTO	PHOTOGRAPHER Mark McDonough		DATE 1986
	VIEW SE	NEGATIVE ON FILE 113	
COMPILED BY	NAME Mark McDonough		DATE 1986
	ORGANIZATION Town of Thompson, Connecticut		
	ADDRESS		
20 SUBSEQUENT FIELD EVALUATION

Three-bay facade, left entry. Entry has heavy-paneled door, rectangular sidelights, paneled pilasters. Plain frieze with raised block at center, flat molded cap. Sash generally recent 6-over-6. Plain corner pilasters.

Molded architrave, plain frieze; molded cornice shows full return. Lower two-story parallel rear wing has simplified detailing, including left-elevation entry with heavy-paneled door, rectangular glazed transom.
