HISTORIC RESOURCES INVENTORY
BUILDING AND STRUCTURES
 HIST-6 NEW 5/77

IDENTIFICATION	1. BUILDING NAME (Common) (Historic)	
	MASONIC TEMPLE	THOMPSON HILL SCHOOL (Fourth District)
	2. TOWN CITY	VILLAGE COUNTY
	THOMPSON	THOMPSON WINDHAM

3. STREET AND NUMBER (and/or location)	
	139 CHASE ROAD (64 CHASE RD.) 105/34-15	
DESCRIPTION	4. OWNER(S)	
	MASONIC TEMPLE CORP. OF THOMPSON, CT c/o Spahl, Charles Thompson, CT 06277 <input type="checkbox"/> Public <input checked="" type="checkbox"/> Private

CONTINUATION SHEET #19 THOMPSON HILL SCHOOL (FOURTH DISTRICT)
 Item number: _____ Date: _____

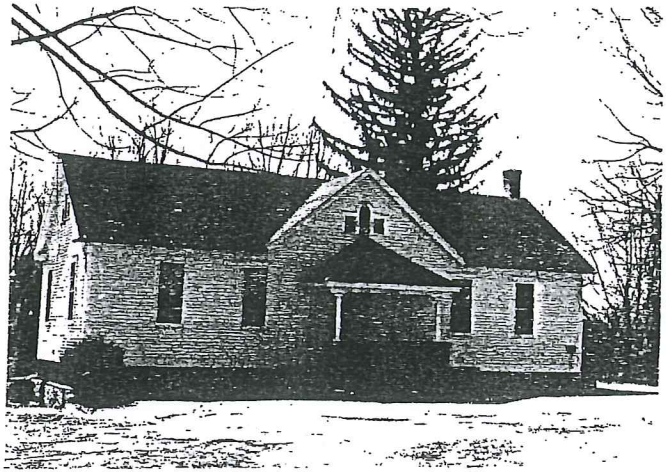
PHOTO	PHOTOGRAPHER Mark McDonough	DATE 1986
	VIEW S	NEGATIVE ON FILE L 20
COMPILED BY	NAME Mark McDonough	DATE 1986
	ORGANIZATION Town of Thompson, Connecticut	
	ADDRESS

11. NUMBER OF STORIES APPROXIMATE DIMENSIONS		
1 1/2 62' x 28'		
12. CONDITION (Structural) (Exterior)		
<input type="checkbox"/> Excellent <input checked="" type="checkbox"/> Good <input type="checkbox"/> Fair <input type="checkbox"/> Deteriorated <input type="checkbox"/> Excellent <input checked="" type="checkbox"/> Good <input type="checkbox"/> Fair <input type="checkbox"/> Deteriorated

17 OTHER NOTABLE FEATURES OF BUILDING OR SITE (interior and/or exterior)
 Five-bay facade, central entry. Entry portico has fieldstone railing, concrete steps; slender round posts have capitals with scrolls and quatrefoil cut-outs. Above portico, gabled wall dormer has Palladian style window with molded surround. Sash generally 6-over-6; windows have flat molded caps. Plain frieze; molded cornice shows partial return. Side elevations have similar detailing, including Palladian style attic windows plain side entry on right. Cross-gabled rear wing.
