HISTORIC RESOURCES INVENTORY
BUILDING AND STRUCTURES
HIST-6 NEW 5/77

ROYAL S. WATSON HOUSE

THOMPSON THOMPSON WINDHAM

69 CHASE ROAD (32 CHASE RD.)

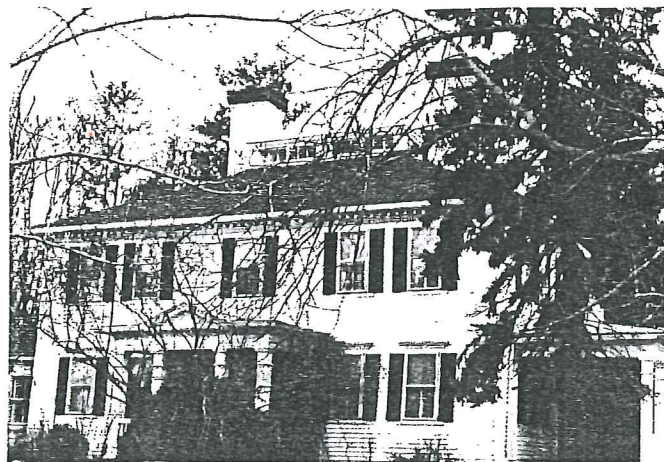
PHOTO	PHOTOGRAPHER Mark McDonough		DATE 1986
	VIEW SW	NEGATIVE ON FILE I7	
COMPILED BY	NAME Mark McDonough		DATE 1986
	ORGANIZATION Town of Thompson, Connecticut		
	ADDRESS

☐ Excellent ☒ Good ☐ Fair ☐ Deteriorated ☐ Excellent ☒ Good ☐ Fair ☐ Deteriorated

DESCRIPTION (Continued)	17 OTHER NOTABLE FEATURES OF BUILDING OR SITE (interior and/or exterior)
	Five-bay facade, central entry, sash generally 2-over-2. First floor windows have flat molded caps with delicate dentils. One story entry porch on fluted square posts with pedimented peak over entry. Turned balusters, molded rail.
	Portico has molded architrave, plain frieze, dentils cut to plumb under rakes. Heavy paneled wood door, rectangular glazed transom.
	Second floor windows abut bed molding. Main cornice has delicate dentils, modillions. Central monitor like cupola, large twin brick chimneys. Left elevation has side entry with detailing and portico similar to front. Large right rear wing with simpler detailing.
