HISTORIC RESOURCES INVENTORY
BUILDING AND STRUCTURES
 HIST-6 NEW 5/77

IDENTIFICATION	1. BUILDING NAME (Common) (Historic)		NATHANIEL MILLS HOUSE	
	2. TOWN CITY	VILLAGE	COUNTY	
	THOMPSON	EAST THOMPSON	WINDHAM	
	3. STREET AND NUMBER (and/or location)		120/21-26	
	1460 EAST THOMPSON ROAD (68 EAST THOMPSON Rd.)

5. USE (Present)		(Historic)	
	Residence		Residence	
	6. ACCESSIBILITY TO PUBLIC:		IF YES, EXPLAIN	
<input checked="" type="checkbox"/> Yes <input type="checkbox"/> No		<input type="checkbox"/> Yes <input checked="" type="checkbox"/> No		
DESCRIPTION	7. STYLE OF BUILDING		DATE OF CONSTRUCTION	
	Greek Revival		c. 1840

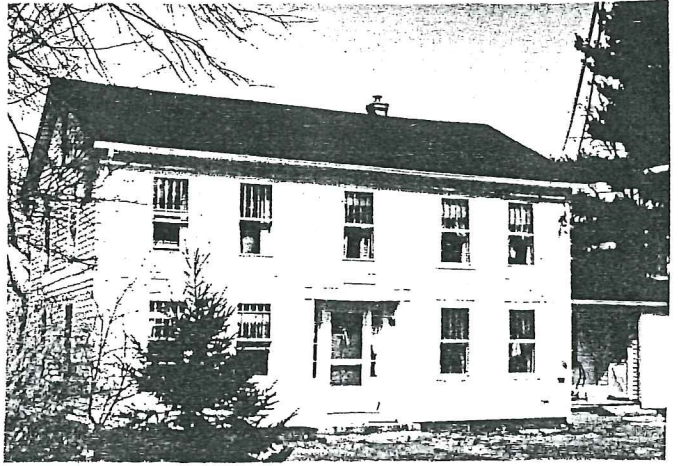
PHOTO	PHOTOGRAPHER Mark McDonough		DATE 1986
	VIEW N	NEGATIVE ON FILE J4	
COMPILED BY	NAME Mark McDonough		DATE 1986
	ORGANIZATION Town of Thompson, Connecticut		
	ADDRESS

11. NUMBER OF STORIES		APPROXIMATE DIMENSIONS		
2 1/2		37' x 25'		
12. CONDITION (Structural) (Exterior)				
<input type="checkbox"/> Excellent	<input checked="" type="checkbox"/> Good	<input type="checkbox"/> Fair	<input type="checkbox"/> Deteriorated	
<input type="checkbox"/> Excellent	<input checked="" type="checkbox"/> Good	<input type="checkbox"/> Fair	<input type="checkbox"/> Deteriorated

13. INTEGRITY (Location)		WHEN ?	(Alterations) IF YES, EXPLAIN	
<input checked="" type="checkbox"/> On original site	<input type="checkbox"/> Moved		<input checked="" type="checkbox"/> Yes <input type="checkbox"/> No Wood shingles, sash later

Five-bay facade, recessed central entry has sidelights, paneled surround, with central paneled tablet, paneled corner blocks. Sash generally five narrow vertical panes over one (c. 1925). House clad in alternating courses of plain and staggered-butts wood shingles. Plain frieze and corner boards. Molded cornice shows partial return.

Single chimney offset right. Left elevation has old 6-over-6 attic sash. One story parallel kitchen wing to right with additional entry.
