HISTORIC RESOURCES INVENTORY  
BUILDING AND STRUCTURES  
HIST-6 NEW 5 77

1. BUILDING NAME (Common)		(Historic)	
THOMPSON		ELIJAH CROSBY HOUSE	
2. TOWN CITY	VILLAGE	COUNTY	
THOMPSON	QUADDICK	WINDHAM	
3. STREET AND NUMBER (and/or location)		124/32-26	
440 QUADDICK ROAD & O'LEARY ROAD (316 QUADDICK RO.)

ELIJAH CROSBY HOUSE

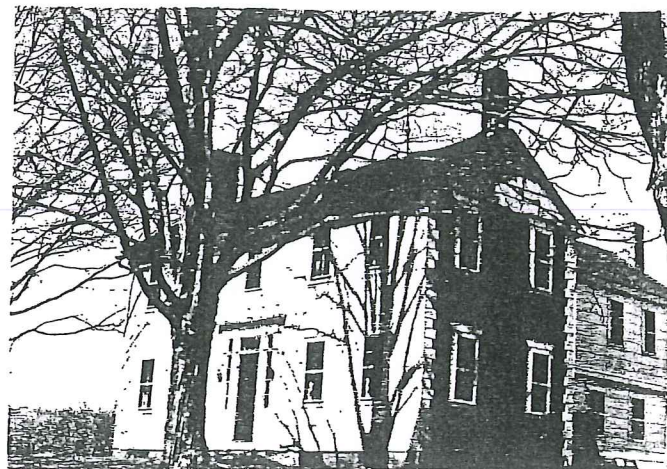
PHOTO	PHOTOGRAPHER Mark McDonough		DATE 1986
	VIEW NW	NEGATIVE ON FILE L21	
COMPILED BY	NAME Mark McDonough		DATE 1986
	ORGANIZATION Town of Thompson, Connecticut		
	ADDRESS

11. NUMBER OF STORIES		APPROXIMATE DIMENSIONS	
2 1/2		37' x 16' (main); 18' x 33' (rear wing)	
12. CONDITION (structural)			
(Exterior)			
<input type="checkbox"/> Excellent <input checked="" type="checkbox"/> Good <input type="checkbox"/> Fair <input type="checkbox"/> Deteriorated <input type="checkbox"/> Excellent <input checked="" type="checkbox"/> Good <input type="checkbox"/> Fair <input type="checkbox"/> Deteriorated

DESCRIPTION (Continued)	17 OTHER NOTABLE FEATURES OF BUILDING OR SITE (interior and/or exterior)
	<p>Five-bay, central entry, window bays paired and offset towards the corners of house. Sash generally 2-over-2, splayed wood lintels. Wooden quoins. Second floor windows located high under eaves. Paneled wood door, sidelights over panels, flanked by narrow pilasters. Molded transom bar, rectangular glazed transom, flat molded cap. Endwalls are brick, with similar detailing. Very large cross-gabled rear wing comprises bulk of house.</p>
