**HISTORIC RESOURCES INVENTORY**  
**BUILDING AND STRUCTURES**  
 HIST-6 NEW 5/77

IDENTIFICATION	1. BUILDING NAME (Common) <span style="float: right;">(Historic)</span>		ALPHEUS RUSSELL HOMESTEAD		
	2. TOWN CITY	VILLAGE	COUNTY		
	THOMPSON		WINDHAM

3. STREET AND NUMBER (and/or location)		126/15-78		
	168 HILL ROAD <span style="float: right;">(196 Hill Rd.)</span>				
	4. OWNER(S)		<input type="checkbox"/> Public <input checked="" type="checkbox"/> Private		
	SIEGEL, STEPHANIE G., RR2, THOMPSON, CT 06277

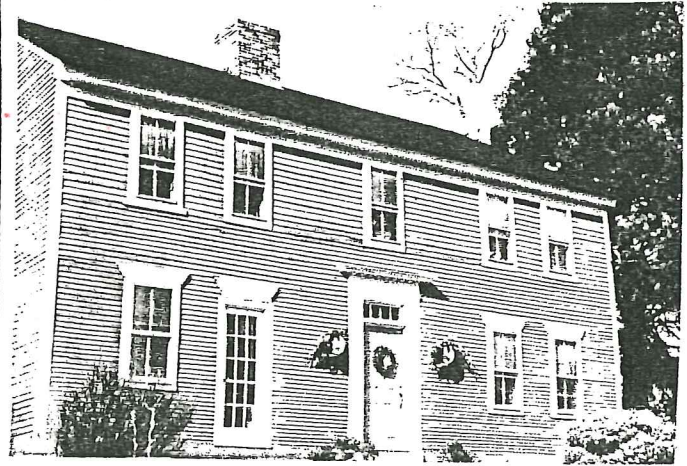
PHOTO	PHOTOGRAPHER Mark McDonough		DATE 1986
	VIEW N	NEGATIVE ON FILE I 32	
COMPILED BY	NAME Mark McDonough		DATE 1986
	ORGANIZATION Town of Thompson, Connecticut		
	ADDRESS

11. NUMBER OF STORIES		APPROXIMATE DIMENSIONS			
2 1/2		38' x 30'			
12. CONDITION (Structural) <span style="float: right;">(Historic)</span>					
<input type="checkbox"/> Excellent <input checked="" type="checkbox"/> Good <input type="checkbox"/> Fair <input type="checkbox"/> Deteriorated <input type="checkbox"/> Excellent <input checked="" type="checkbox"/> Good <input type="checkbox"/> Fair <input type="checkbox"/> Deteriorated

13. INTEGRITY (Location)		WHEN ?	(Alterations)	IF YES, EXPLAIN	
<input checked="" type="checkbox"/> On original site <input type="checkbox"/> Moved			<input checked="" type="checkbox"/> Yes <input type="checkbox"/> No	Some later sash

Five-bay facade, central entry. Sash generally 2-over-2; splayed window lintels on first floor, second floor windows fitted into bed molding. Entry sized window in second bay. Window bays are paired and offset towards corners of house.

Entry has heavy paneled door, molded transom bar, rectangular glazed transom, flat molded cap with delicate flared consoles. Beaded corner boards. Frieze has delicate dentils, then consoles similar to entry cap. Molded cornice shows partial return. Central brick chimney. Small parallel left wing is somewhat altered. Two story right rear wing is old if not original.
