HISTORIC RESOURCES INVENTORY
BUILDING AND STRUCTURES
 HIST-6 NEW 5/77

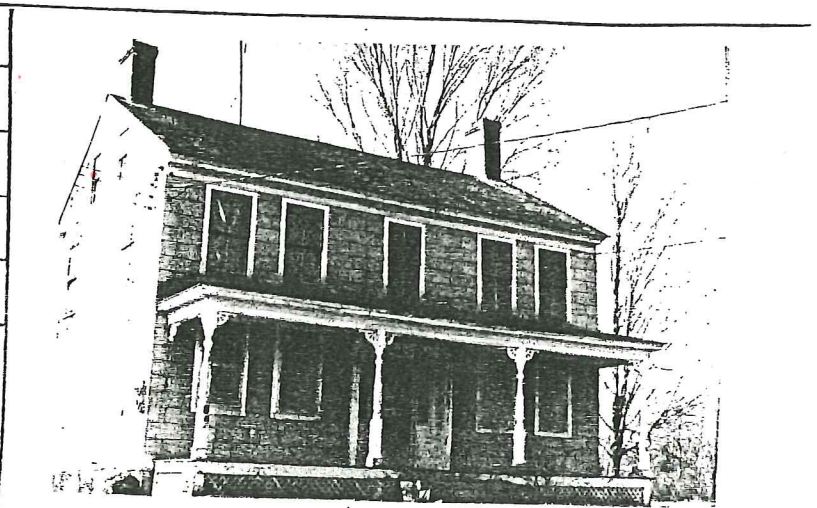
PHOTO	PHOTOGRAPHER		DATE
	Mark McDonough		1986
COMPILED BY	VIEW	NEGATIVE ON FILE	
	NW	I31	
COMPILED BY	NAME		DATE
	Mark McDonough		1986
	ORGANIZATION		
	Town of Thompson, Connecticut		
ADDRESS

Five-bay facade, central recessed entry, window bays paired and offset towards corners of house.

Entry: wood door with single large light over panels, sidelights over panels. Sidelights flanked by narrow paneled pilasters. Sash generally 2-over-2.

Second floor windows located relatively high under the eaves. Full width one story front porch on turned posts. Quarter circle post brackets with radial cut-outs. Molded cornice shows partial return. Twin brick chimneys. Left elevation has old 6-over-6 in small paired attic windows. Cross-gabled one story rear wing with attached shed.
