HISTORIC RESOURCES INVENTORY
BUILDING AND STRUCTURES
 HIST-6 NEW 5/77

IDENTIFICATION	1. BUILDING NAME (Common) EAST THOMPSON CHURCH		(Historic) EAST THOMPSON CHURCH	
	2. TOWN CITY 618 EAST THOMPSON ROAD		VILLAGE EAST THOMPSON	COUNTY WINDHAM

CONTINUATION SHEET #19 EAST THOMPSON CHURCH ✓
 Item number: _____ Date: _____

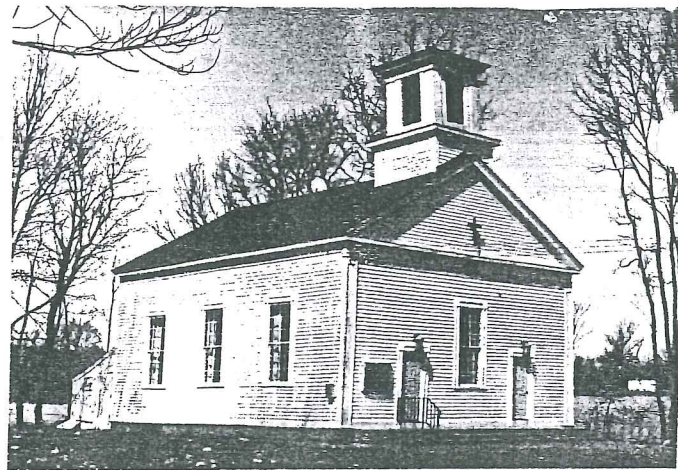
PHOTO	PHOTOGRAPHER Mark McDonough		DATE 1986
	VIEW NW	NEGATIVE ON FILE J12	
COMPILED BY	NAME Mark McDonough		DATE 1986
	ORGANIZATION Town of Thompson, Connecticut		
	ADDRESS

11. NUMBER OF STORIES 2 1/2		APPROXIMATE DIMENSIONS 35' x 42'		
12. CONDITION (Structural) (Historic)				
<input type="checkbox"/> Excellent <input checked="" type="checkbox"/> Good <input type="checkbox"/> Fair <input type="checkbox"/> Deteriorated <input type="checkbox"/> Excellent <input checked="" type="checkbox"/> Good <input type="checkbox"/> Fair <input type="checkbox"/> Deteriorated

13. INTEGRITY (Location)		WHEN ?	(Alterations)	
<input checked="" type="checkbox"/> On original site <input type="checkbox"/> Moved			<input checked="" type="checkbox"/> Yes <input type="checkbox"/> No	
IF YES, EXPLAIN New concrete steps, steel doors

Three-bay facade with left and right entries, central oversized 12-over-12 windows. Doors and windows have plain sills, paneled surrounds, plain corner blocks. Paneled corner pilasters, molded architrave, plain frieze. Molded cornice shows full return.

Steeple: four sided clapboarded based topped by molded cornice, belfry with rectangular louvers flanked by wide plain pilasters. At top, wide plain frieze and molded cornice.
