HISTORIC RESOURCES INVENTORY
BUILDING AND STRUCTURES
HIST-6 NEW 5/77

| IDENTIFICATION | 1. BUILDING NAME (Common) _____ (Historic) _____ | | | |
|---|--|--|--|--|
| | 3. STREET AND NUMBER (and/or location) 438 EAST THOMPSON ROAD (580 EAST THOMPSON RD.) | | 135/4-4 | |
| | 7. STYLE OF BUILDING Vernacular | | DATE OF CONSTRUCTION c. 1800 | |

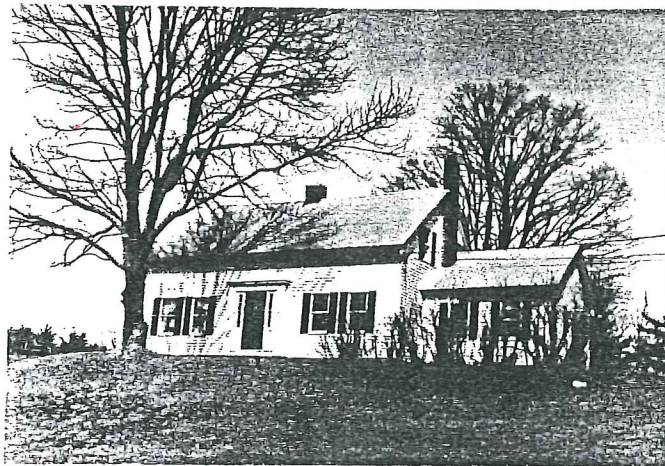
| | VIEW NW & W | NEGATIVE ON FILE J15 & J16 | |

| IDENTIFICATION | 1. BUILDING NAME (Common) _____ (Historic) _____ | | | |
|---|--|--|--|--|
| | 12. CONDITION (Structural) _____ (Exterior) _____ <input type="checkbox"/> Excellent <input checked="" type="checkbox"/> Good <input type="checkbox"/> Fair <input type="checkbox"/> Deteriorated <input type="checkbox"/> Excellent <input checked="" type="checkbox"/> Good <input type="checkbox"/> Fair <input type="checkbox"/> Deteriorated | | | |
| | IF YES, EXPLAIN Later sash, repairs, siding | | | |

17 OTHER NOTABLE FEATURES OF BUILDING OR SITE (interior and/or exterior)
Five-bay facade, central entry, recent 6-over-6 sash. Entry bay framed-out slightly. Old paneled wood door with small rectangular panes top. Rectangular sidelights over panels. Sidelights flanked by narrow fluted pilasters. One story parallel right wing.
