HISTORIC RESOURCES INVENTORY
BUILDING AND STRUCTURES
 HIST-6 NEW 5/77

1. BUILDING NAME (Common) QUADDIC DAM		(Historic) QUADDICK DAM	
2. TOWN CITY THOMPSON		VILLAGE QUADDICK	COUNTY WINDHAM
3. STREET AND NUMBER (and/or location) SOUTH END OF QUADDIC POND		143/16-10A

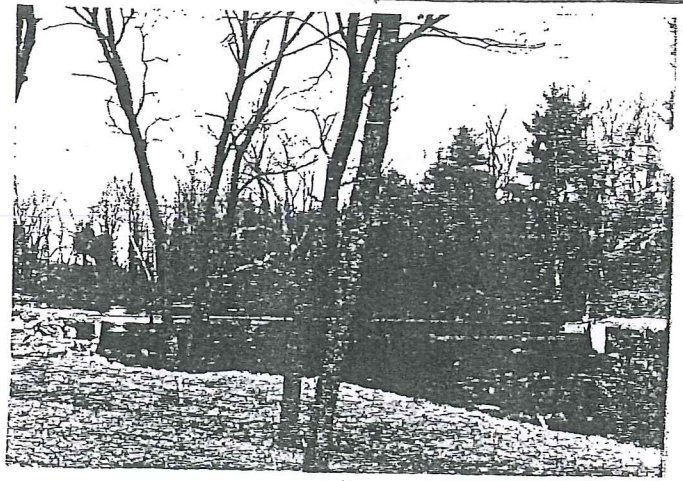
PHOTO	PHOTOGRAPHER Mark McDonough		DATE 1986
	VIEW NE	NEGATIVE ON FILE I25	
COMPILED BY	NAME Mark McDonough		DATE 1986
	ORGANIZATION Town of Thompson, Connecticut		
	ADDRESS

11. NUMBER OF STORIES N/A	APPROXIMATE DIMENSIONS 12' high x 60'		
12. CONDITION (Structural)			
<input type="checkbox"/> Excellent	<input checked="" type="checkbox"/> Good	<input type="checkbox"/> Fair	<input type="checkbox"/> Deteriorated
(Exterior)		<input type="checkbox"/> Excellent	<input checked="" type="checkbox"/> Good <input type="checkbox"/> Fair <input type="checkbox"/> Deteriorated

13. INTEGRITY (Location)		WHEN ?	(Alterations)
<input checked="" type="checkbox"/> On original site	<input type="checkbox"/> Moved		<input checked="" type="checkbox"/> Yes <input type="checkbox"/> No
IF YES, EXPLAIN Modern cast-concrete at crest

Nineteenth century masonry dam with recent cast concrete cap and flashboards. Long axis of dam runs east-west. At west end, modern rip-rap then modern trash rack covering headrace opening of 1985 hydroelectric turbine, which is sheltered by wood frame shed on concrete foundation.

At the east end of dam, old open headrace terminates in modern trash rack. Just upstream, considerably higher 1960 concrete dam impounds large reservoir.
